Subject: Non-Docket Case No. 2024-01872  
Report to the Commission on the August 8, 2023 Lahaina Fires

Hawaiian Electric<sup>1</sup> respectfully submits the attached Report to the Hawai'i Public Utilities Commission on the August 8, 2023 Lahaina Fires ("Report").<sup>2</sup>

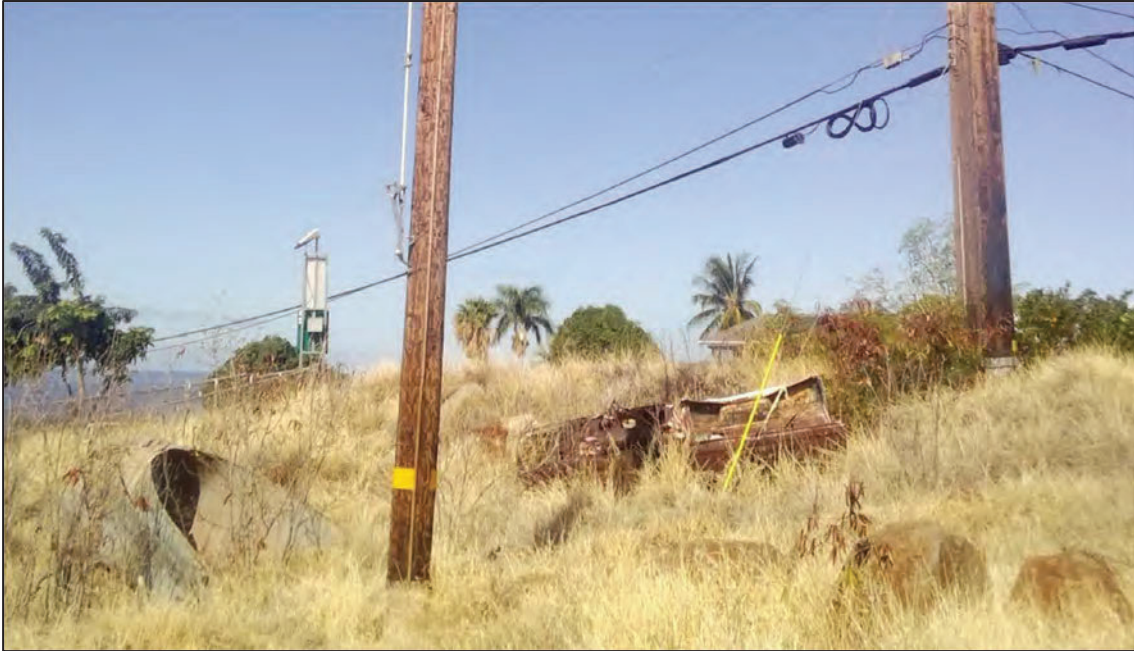
*Figure 10: Photo captured as part of Test and Treat inspection in November 2021 by Osmose of Pole 1-25 (left) and Pole 25 (right) from the Ku'ia field owned by Kamehameha Schools. This photo faces northwest and the Lahainaluna Road speed limit sign is visible over the crest of the hill. The abandoned vehicle and metal piping visible in the brush remained present on August 8, 2023. This brush is near an unmaintained firebreak that MFD ordered cleared in November 2019. The Morning Fire started at the base of Pole 25 and spread downhill towards Pole 1-25 through this unmanaged field.*

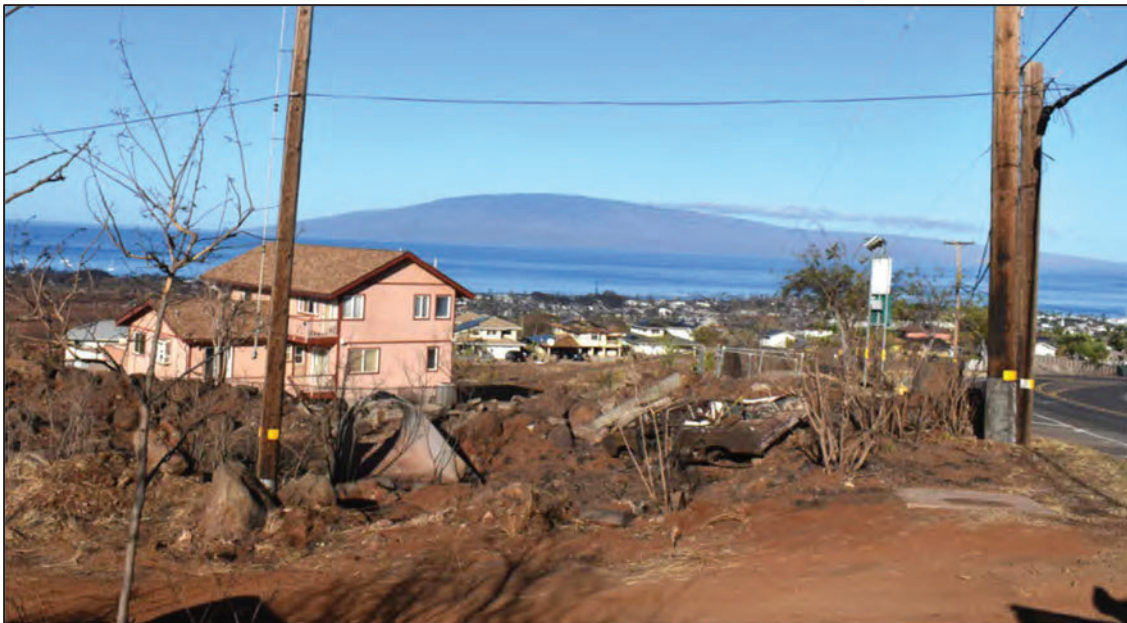
*Figure 11: Photo captured on August 13, 2023, of Pole 1-25 (left) and Pole 25 (right) from Lahainaluna Road east of Pole 25. This photo faces west and shows burned, unmanaged brush, as well as the same abandoned equipment in the Ku'ia field. The unmaintained firebreak is visible in the foreground, and appeared as a dirt road after the brush burned.*

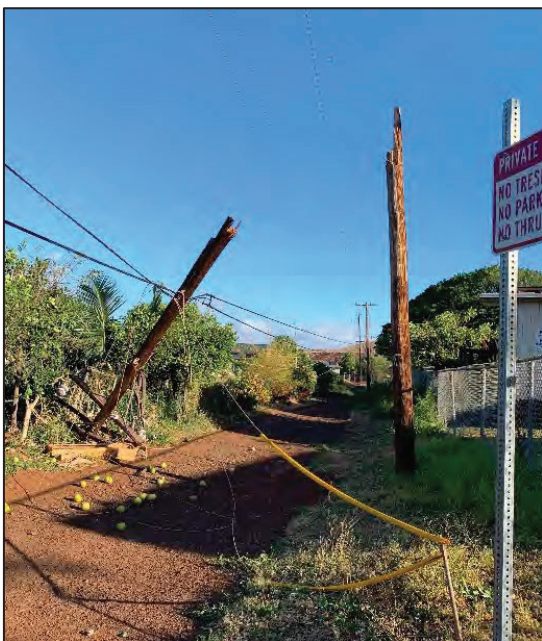
The Troublemán observed Pole 7A on Ho‘okahua Street—the dirt alley that intersects Lahainaluna Road from the north, near the Lahaina Intermediate School—broken in half with the top section inverted and supported by telecommunication lines. Pole 25, south of Lahainaluna Road, which had been erroneously reported by MFD dispatch to Hawaiian Electric as broken, was intact. All three phases of [REDACTED] and the neutral ground wire between Pole 25 and Pole 7A toward Ho‘okahua Street had broken. At Pole 7A, the de-energized and disconnected distribution conductors were on the ground in the dirt alley to the north of Lahainaluna Road near the top portion of the broken pole, which had fallen to the ground as shown in Figure 13. Electrically, Pole 7A is load-side, or downstream, of Pole 25; the conductors on the ground by Pole 7A were not electrically connected to any source. There was no indication of fire in the immediate area of Pole 7A, and this area did not burn later in the day. At Pole 25, short sections of the three broken aluminum conductors and broken neutral remained attached to the pole, as shown in Figure 14. These broken conductors were electrically connected by jumpers to two [REDACTED] conductors that ran parallel to Lahainaluna Road. The third conductor—the field-side, southernmost phase of [REDACTED] along Lahainaluna Road—had separated, and hung from either end to Pole 24 and Pole 26.

*Figure 13: 7:29 a.m. photo captured by a Hawaiian Electric Troublemán showing Pole 7A snapped in half. The base of Pole 7A remains upright and in the ground*

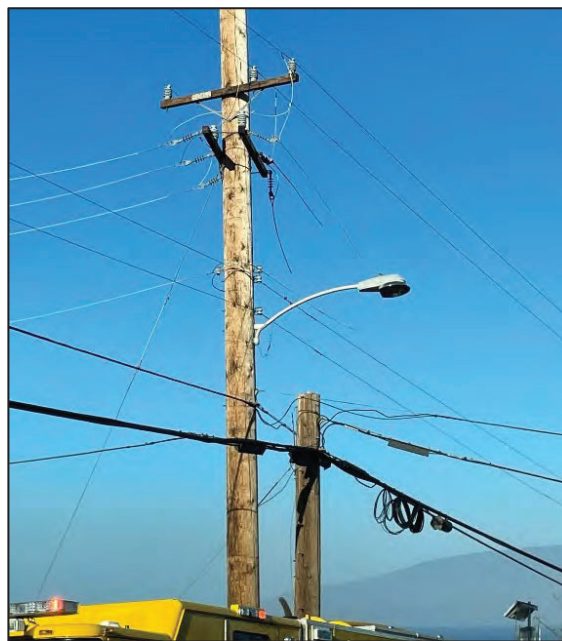
*Figure 14: 7:19 a.m. photo captured by a Hawaiian Electric Troublemán showing short dead-end conductors hanging from Pole 25, as well as the southernmost (field-side) phase between Pole 24 and Pole 26 missing from the insulator*

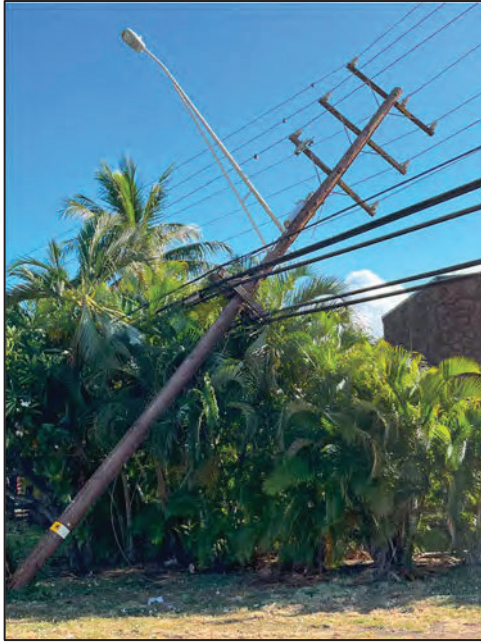
*Figure 16: 8:00 a.m. photo captured by Hawaiian Electric foreman of Pole 13 leaning at the intersection of Honoapiilani Highway and Keawe Street*

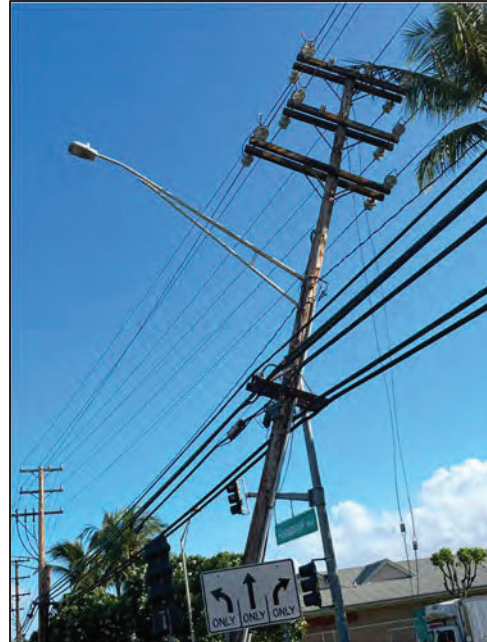
*Figure 17: 8:01 a.m. photo captured by Hawaiian Electric foreman of Pole 14 leaning at the intersection of Honoapiilani Highway and Keawe Street*

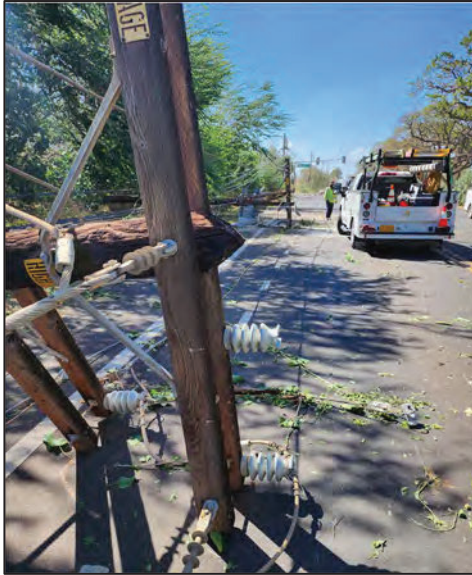
*Figure 18: Photo captured by a Hawaiian Electric substation engineer at 9:25 a.m. of a series of poles across Honoapiilani Highway near the intersection with Hokiokio Place*

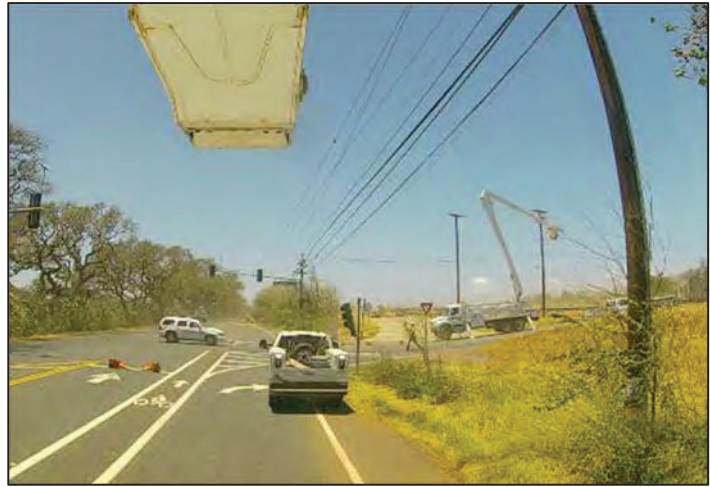
*Figure 19: A 12:59 p.m. dashcam photo captured by a contractor showing poles down across Honoapiilani Highway and a MPD cruiser stopping traffic*

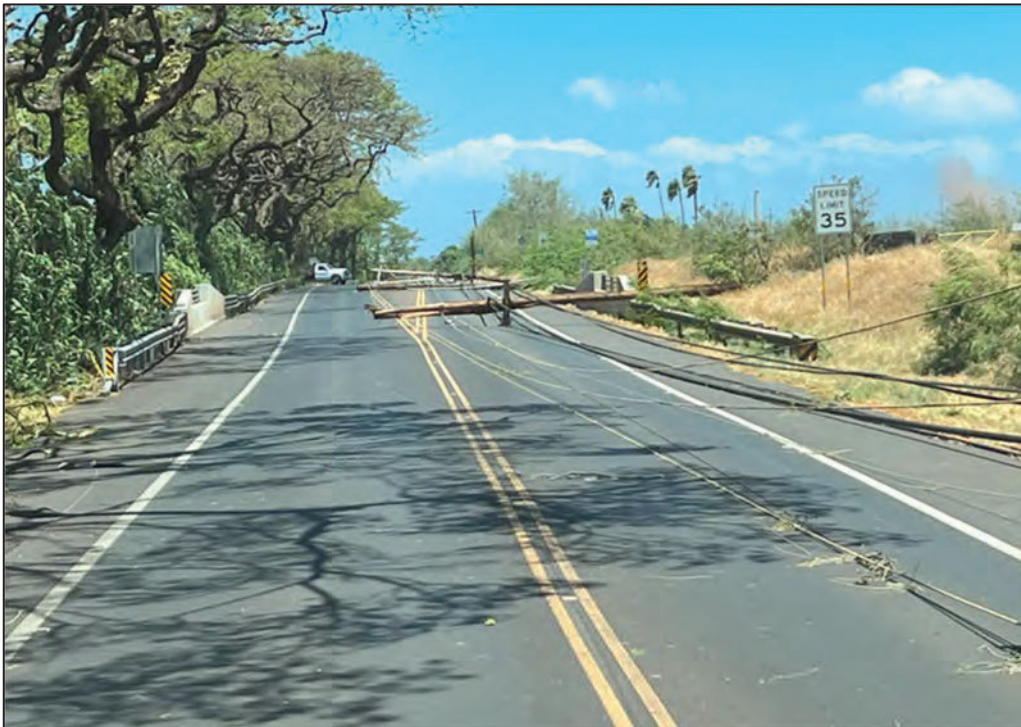
*Figure 20: Photo captured at 11:40 a.m. by a Hawaiian Electric foreman of lines and poles down on Honoapiilani Highway*

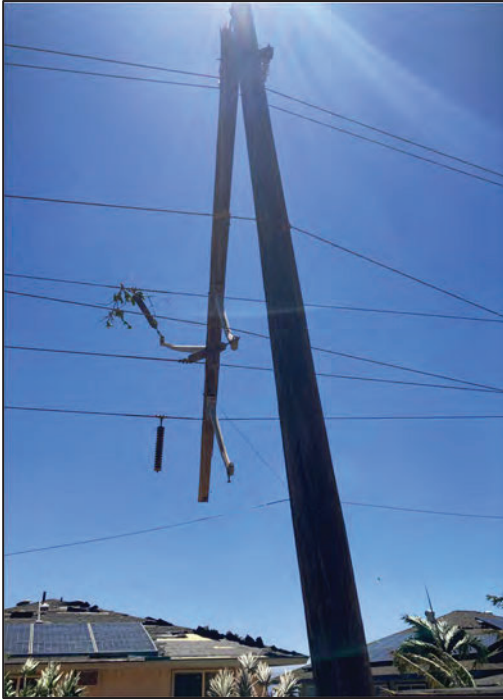
*Figure 21: 2:18 p.m. photo captured by a Hawaiian Electric foreman of Pole 9 on Niheu Place leaning into the backyard of a residence*

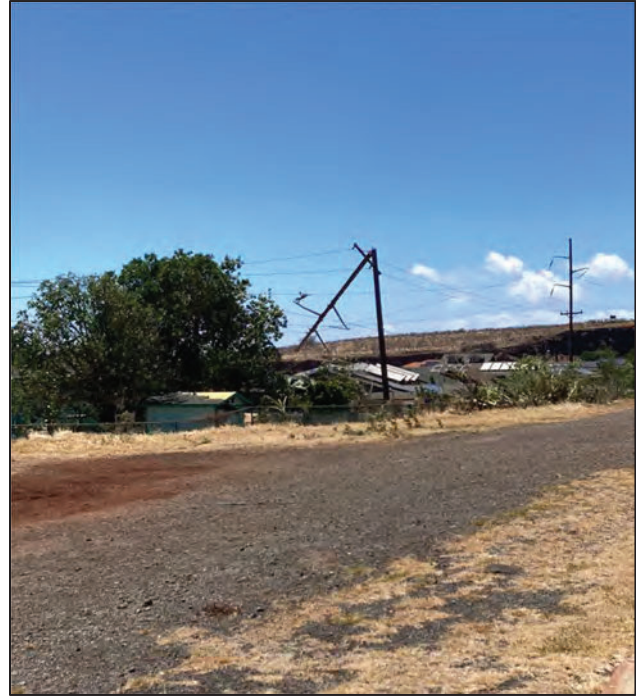
*Figure 22: 2:10 p.m. photo captured by a Hawaiian Electric foreman of Pole 9 on Niheu Place leaning into the backyard of a residence*

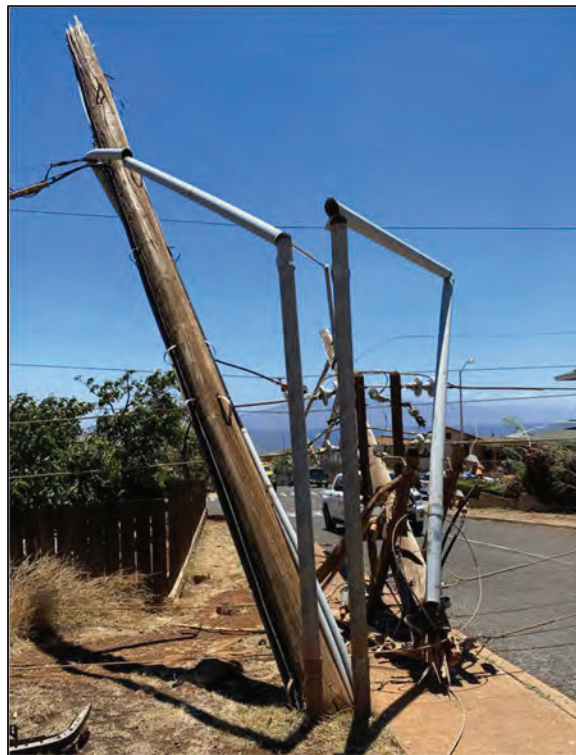
*Figure 23: 1:21 p.m. photo captured by a Hawaiian Electric foreman of Pole 8 at Kumukahi Street and Ho'okahua Street leaning toward the backyard of a residence*

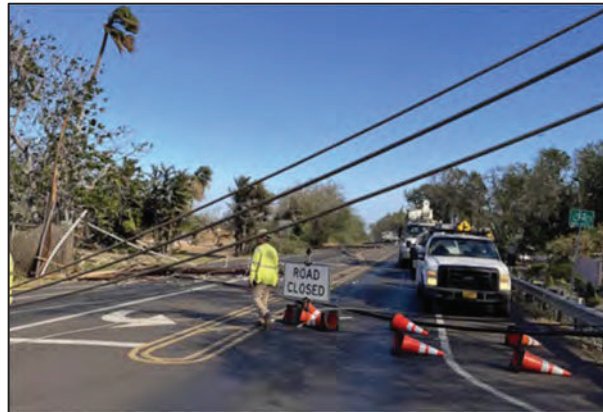
*Figure 34: 4:33 p.m. south-facing photo captured by a Hawaiian Electric contractor showing additional poles and power lines down, as well as low-hanging telecommunications lines at Aholo Road fully blocking Honoapiilani Highway*

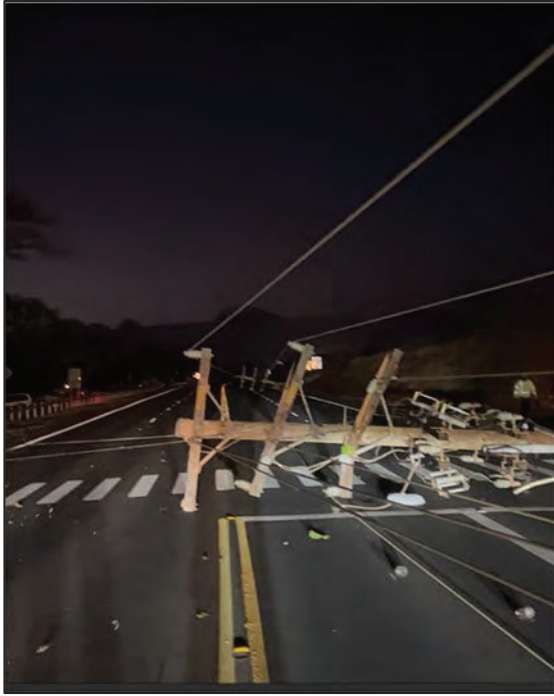
*Figure 37: Still frame from a video captured by a Hawaiian Electric Lineman at approximately 7:49 p.m. of poles down in front of the Lahaina Civic Center on Honoapiilani Highway (looking north towards Kaanapali)*

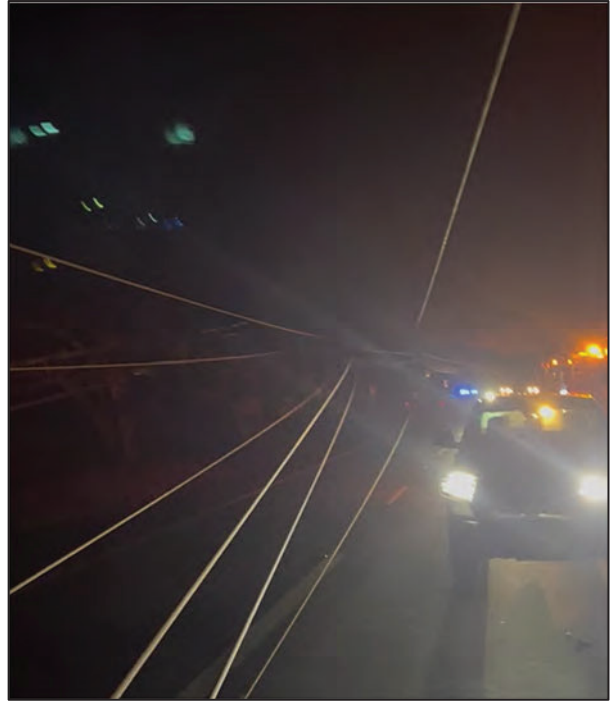
*Figure 38: Still frame from a video captured by a Hawaiian Electric Lineman at approximately 7:49 p.m. of poles down in front of the Lahaina Civic Center on Honoapiilani Highway (looking south towards Lahaina town)*

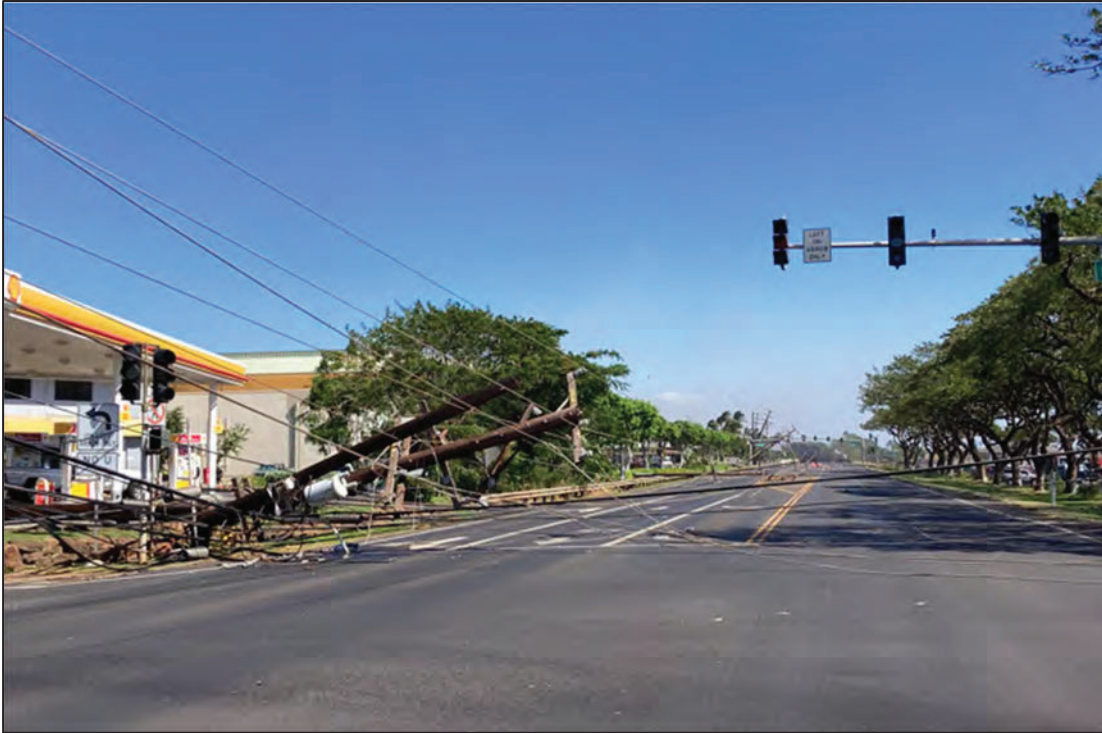
*Figure 39: Photo by a Hawaiian Electric Troublemaker from approximately 3:22 p.m. of additional poles down at the intersection of Honoapiilani Highway and Kapunakea Street (exact metadata not available) that could be bypassed via the Safeway parking lot*

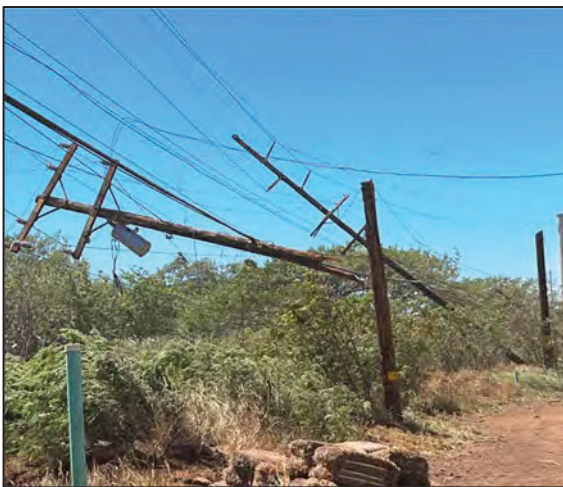
*Figure 40: Photo captured by a Hawaiian Electric foreman at 2:27 p.m. of damaged poles and lines on Mill Street*

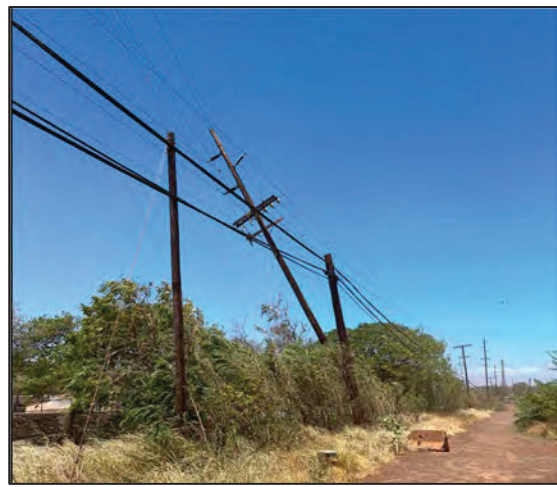
*Figure 41: Photo captured by a Hawaiian Electric foreman at 12:37 p.m. of damaged poles and lines on Mill Street*

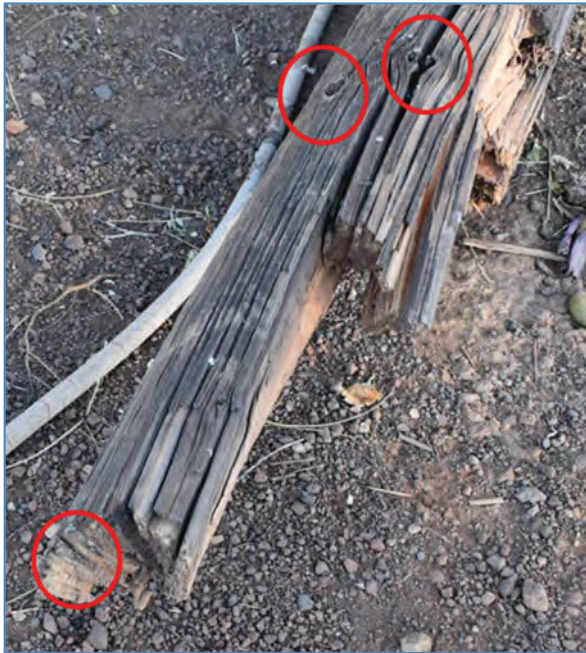
*Figure 45: August 13, 2023 field photograph of the bottom Pole 7A fracture surface. For ease of reference, identified knots are indicated by red circles.*

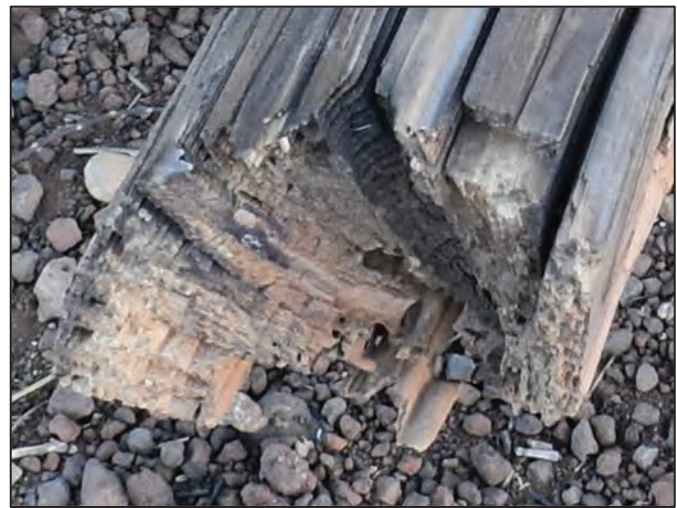
*Figure 46: August 13, 2023 field photograph of the bottom Pole 7A fracture surface with the bored through-bolt hole visible*

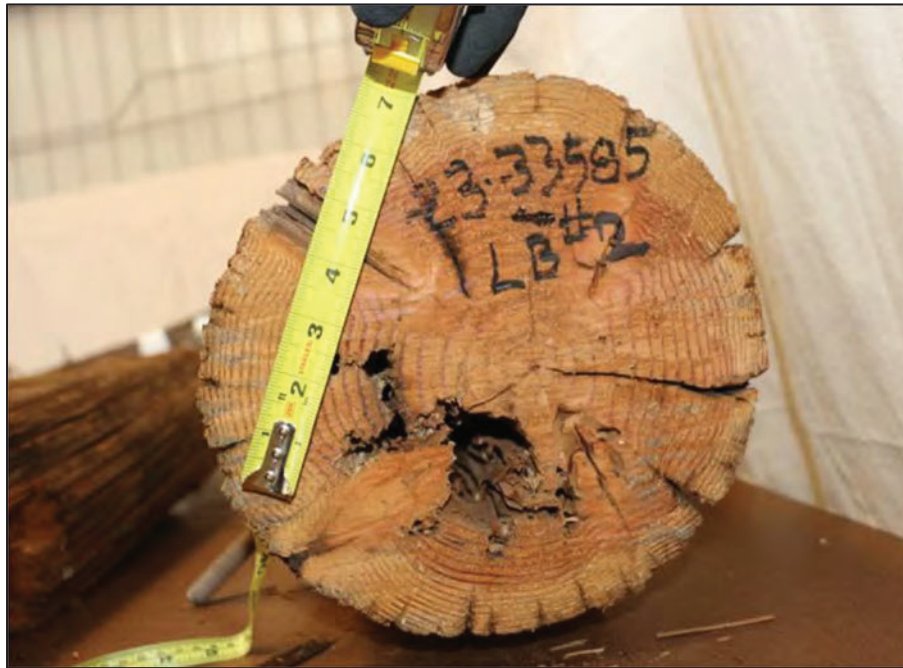
termite species throughout the Hawaiian Islands. The observed termite damage affecting portions of the interior of the pole is not believed to be a significant factor in its failure.

*Figure 47: Photo captured February 2024. The photo presents a cross-section of Pole 7A above its fracture point. The photographed cut was made shortly after the August 8 fires when Pole 7A was removed from the field. An enclosed pocket, of mild to moderate termite damage is visible in the bottom left quadrant of the pole. Because the outer shell of Pole 7A is fully intact, the bulk of the pole's strength remained.*

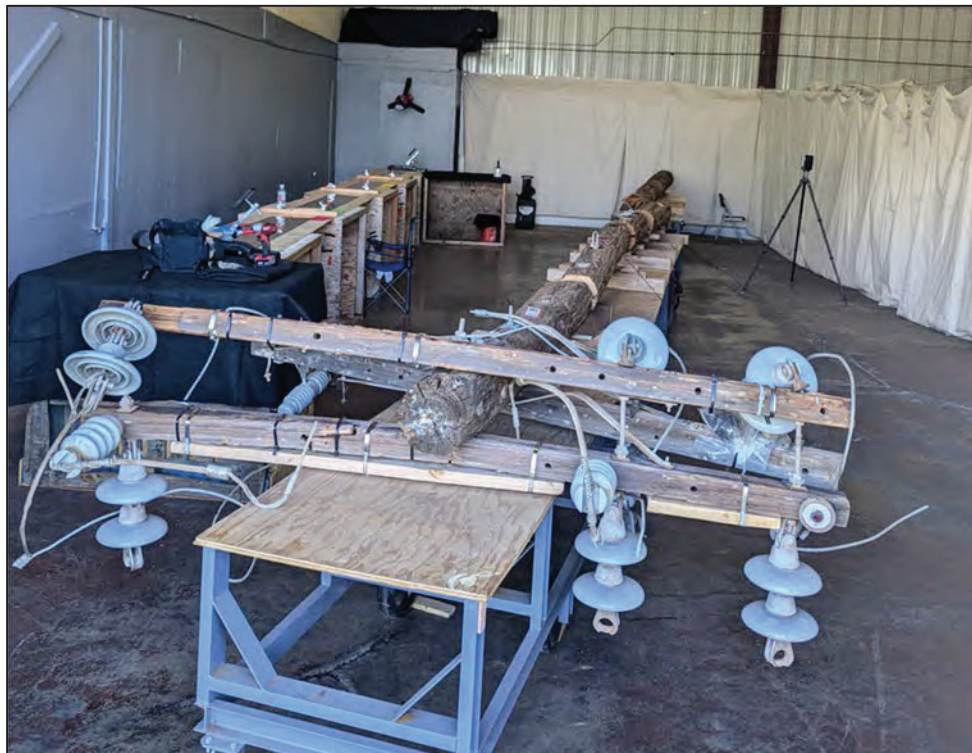
*Figure 48: Pole 7A re-assembled for examination by parties to the civil litigation on June 21, 2024*

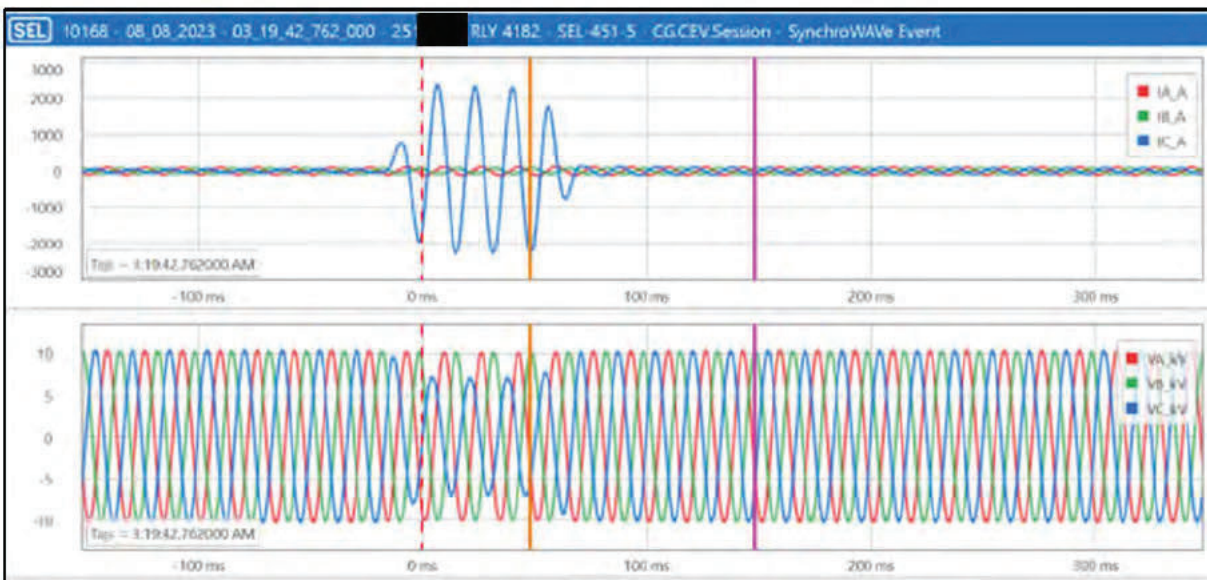
Figure 49: Waveform downloaded from [REDACTED] relay showing the 3:19 a.m. C-Phase to Ground fault

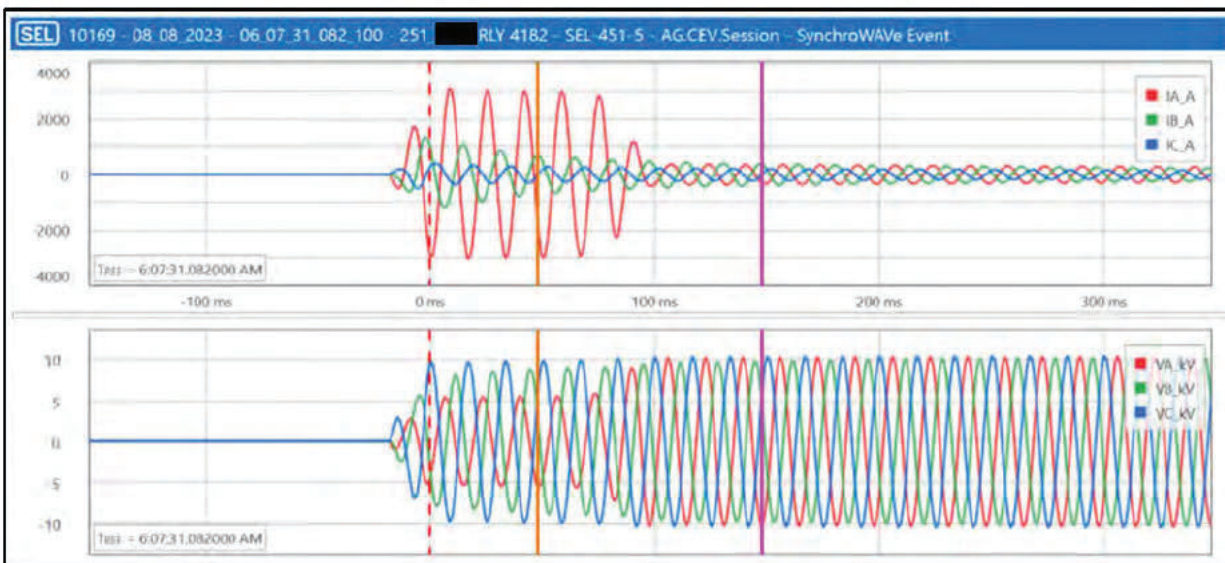
Figure 50: Waveform downloaded from [REDACTED] relay showing the 6:07 a.m. A-Phase to Ground fault

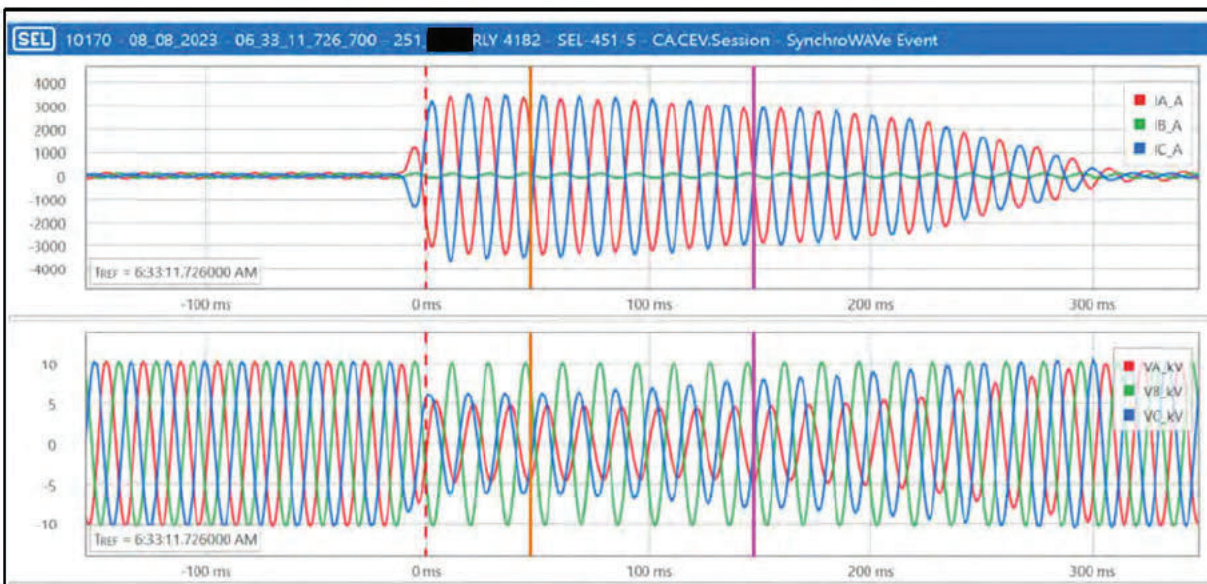
Figure 51: Waveform downloaded from the [REDACTED] relay showing the 6:33 a.m. fault between A-Phase and C-Phase

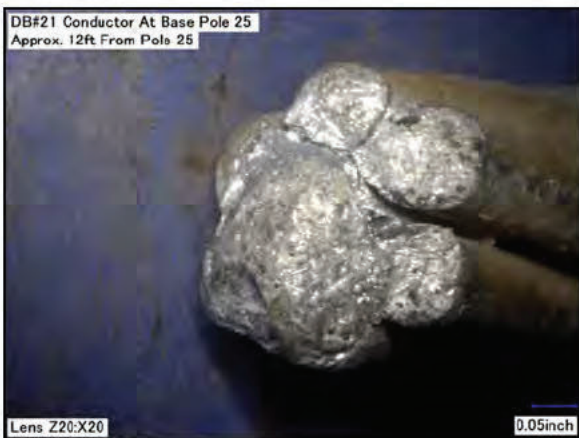
Figure 52: Microscope image of FCA Artifact DB#21, C-Phase dead-end conductor attached to Pole 25 that exhibited melting associated with phase-to-phase fault current

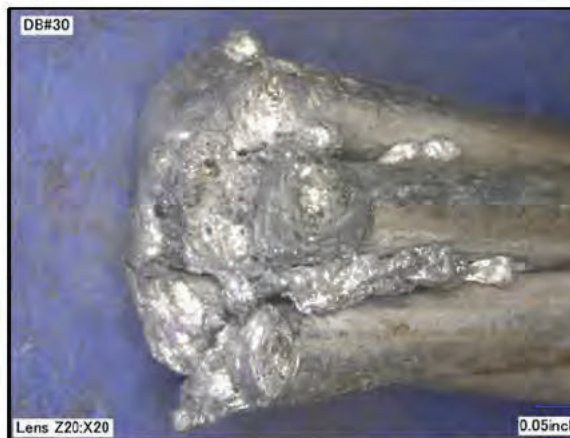
Figure 53: Microscope image of FCA Artifact DB#30, A-Phase dead-end conductor attached to Pole 25 exhibiting melting associated with phase-to-phase fault current

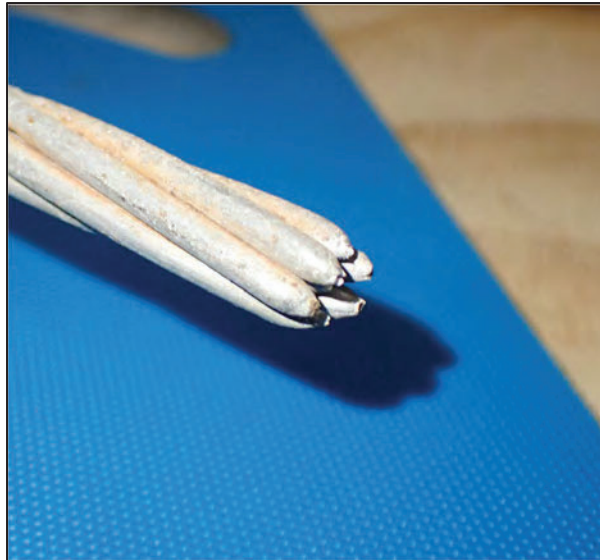
*Figure 54: Image of FCA Artifact DB#29, B-Phase dead-end conductor attached to Pole 25 that did not exhibit melting and appeared to have experienced tensile failure*

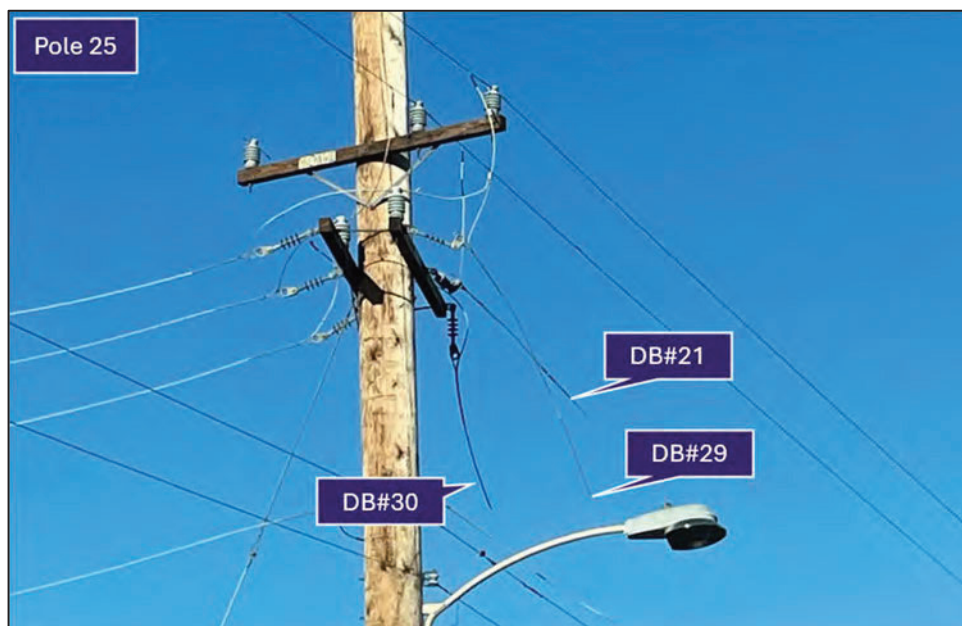
*Figure 55: 7:19 a.m. photo from August 8, 2023 captured by a Hawaiian Electric Troublemaker with short dead-end conductors hanging from Pole 25 labeled with FCA artifact numbers*

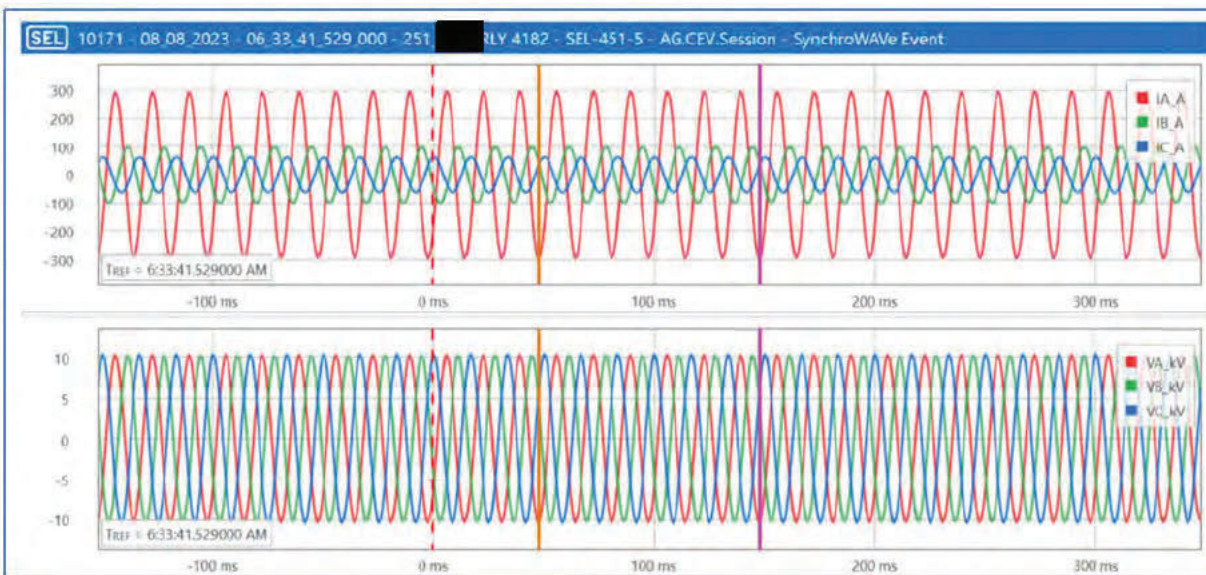
Figure 56: Waveform downloaded from the [REDACTED] relay showing a representative 6:33 a.m. high impedance fault from A-Phase to ground

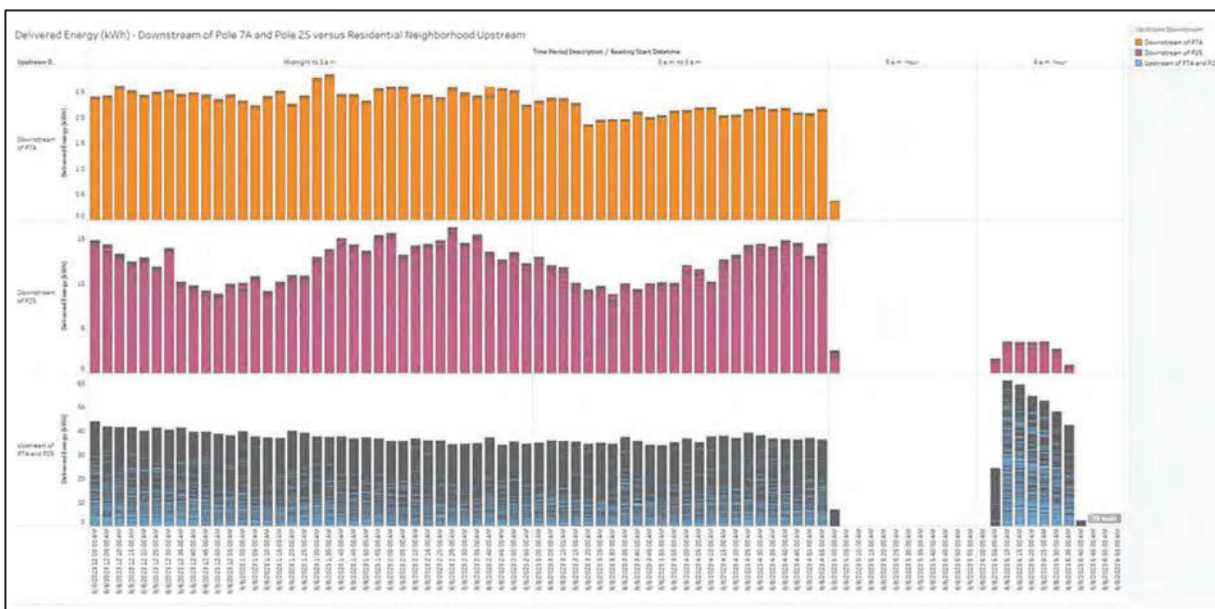
Figure 57: AMI data showing power consumption by certain meters in Lahaina. Meters downstream of Pole 7A (orange) show power consumption until 5:00 a.m., and not upon restoration at 6:07 a.m. Meters upstream of Pole 7A and Pole 25 (blue), as well as meters just upstream of Pole 25 (pink) show power consumption until 5:00 a.m., as well as upon restoration at 6:07 a.m.
