Subject: Non-Docket Case No. 2024-01872  
Report to the Commission on the August 8, 2023 Lahaina Fires

Hawaiian Electric<sup>1</sup> respectfully submits the attached Report to the Hawai'i Public Utilities Commission on the August 8, 2023 Lahaina Fires ("Report").<sup>2</sup>

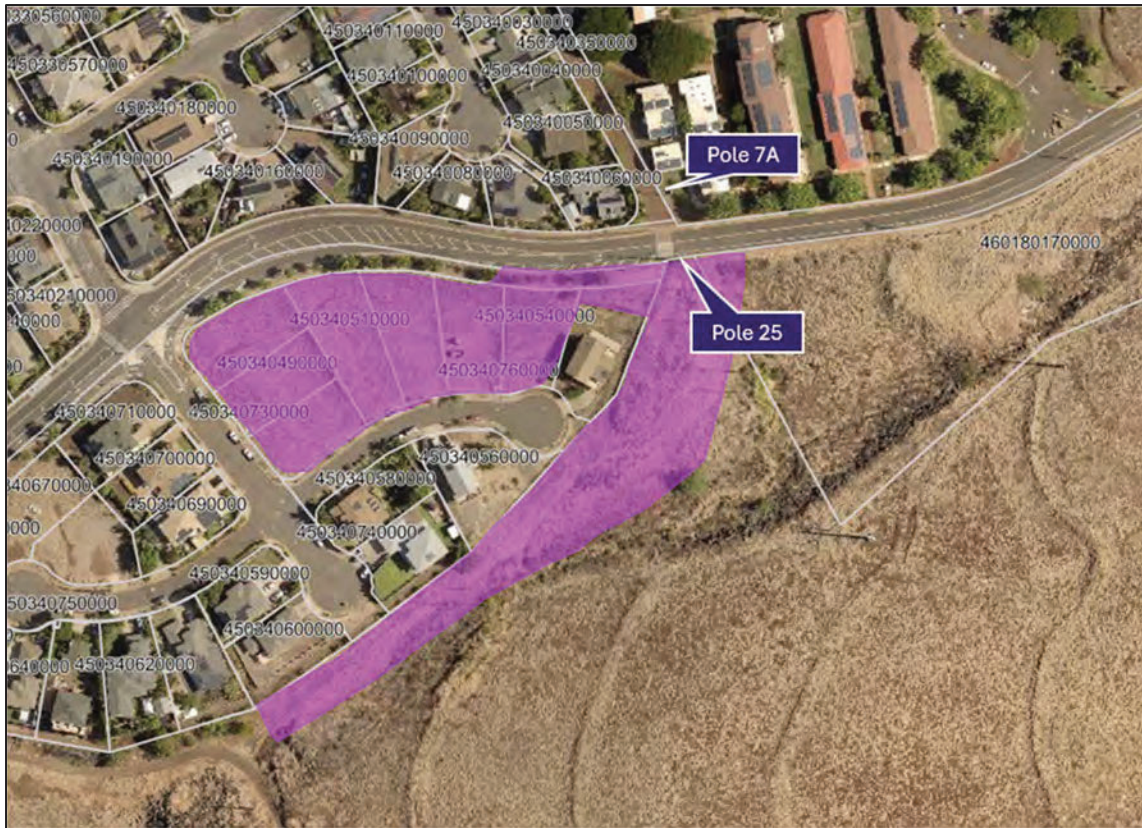
*Figure 9: Parcel map showing Ho'okahua Street, Kuialua Street, and Ho'okahua Place cul-de-sacs on the wildland-urban interface, with the approximate burn area of the Morning Fire shaded in magenta*

The burn area of the Morning Fire roughly extended from the rocky gully to the northeast, around a parcel that borders a parcel owned by the State of Hawai'i, and to Kuialua Street to the southwest, approximately 130,000 square feet (or 3 acres) in total.<sup>36</sup> According to the ATF, a local resident also arrived at the scene with a bulldozer to support MFD's response to the Morning Fire by cutting a firebreak around the approximate perimeter of the Morning Fire. The northeast edge of this firebreak ran along the precipice of a rocky gully in the Ku'ia field. This gully contained accumulated dry and dead vegetation from the unmaintained field. The ATF concluded that the Afternoon Fire would later re-ignite within this rocky gully to the northeast—just beyond the burn area of the Morning Fire. The ATF could not rule out that operation of the resident's bulldozer pushed combustible material into the gully where it was left to smolder for hours.<sup>37</sup>

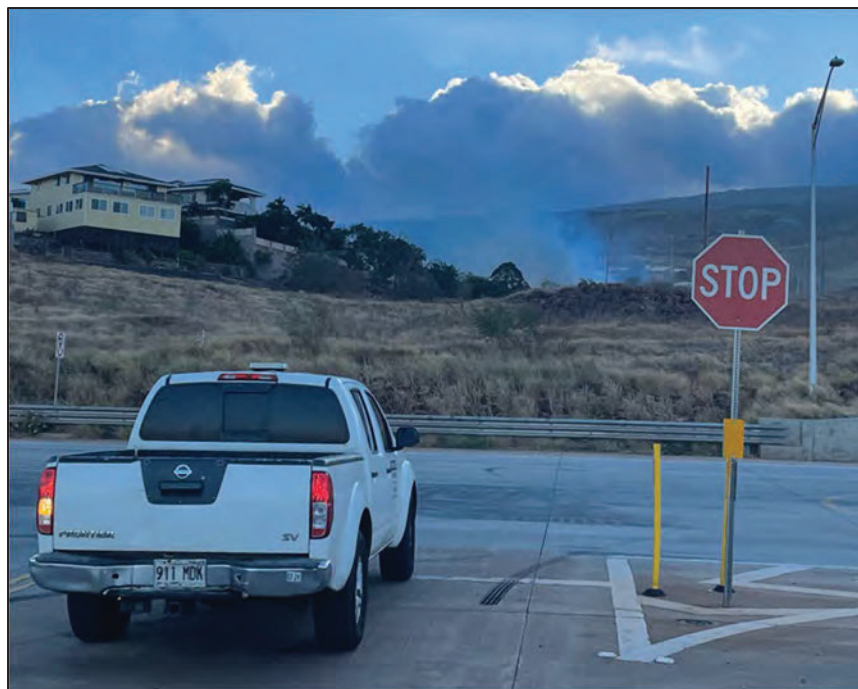
*Figure 12: 6:53 a.m. photograph captured by a Hawaiian Electric Troubleman from the Lahaina Bypass showing smoke from the Morning Fire*

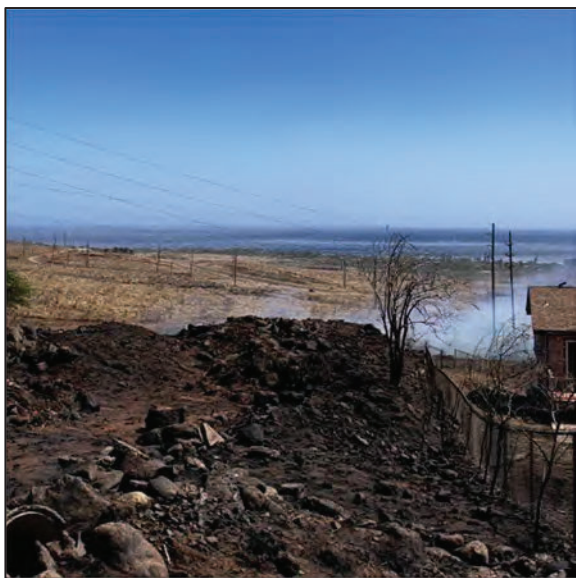
After MFD departed the area of the Morning Fire, Hawaiian Electric crew members in the area observed smoke emerging from the gully adjacent to the burn scar of the Morning Fire shortly before 3:00 p.m. Publicly released 911 calls indicate that the Afternoon Fire was first reported at 2:53 p.m.<sup>41</sup> The caller stated that the Fire Department had been “at the end of the street for a long time because we’ve been having flare ups, but now they’re all gone.”<sup>42</sup> A video recorded at 2:57 p.m. by a Hawaiian Electric crew member shows white smoke emerging from the gully and being pushed towards Lahaina by a strong east wind. This video, as well as those taken by an additional lineman and Troubleman, was provided to ATF and appears in the ATF Report. Two Hawaiian Electric crew members in the area called 911 to report the Afternoon Fire at 2:55 p.m. and 2:57 p.m., respectively. One crew member called from Lahainaluna Road.<sup>43</sup> A second called from the [REDACTED] Substation.<sup>44</sup>

*Figure 24: Still frame from a 2:57 p.m. video captured by a Hawaiian Electric foreman from Lahainaluna Road. This is believed to be the first recording of the Afternoon Fire*

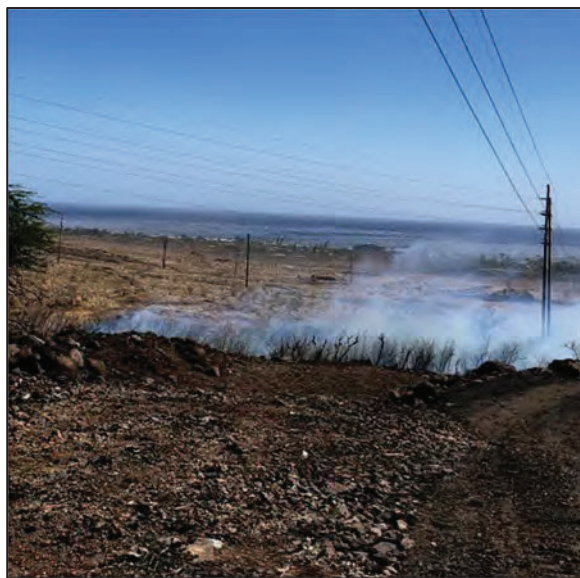
*Figure 25: Still frame from a 2:58 p.m. video captured after the same Hawaiian Electric foreman advanced into the Ku'ia field towards the Afternoon Fire*

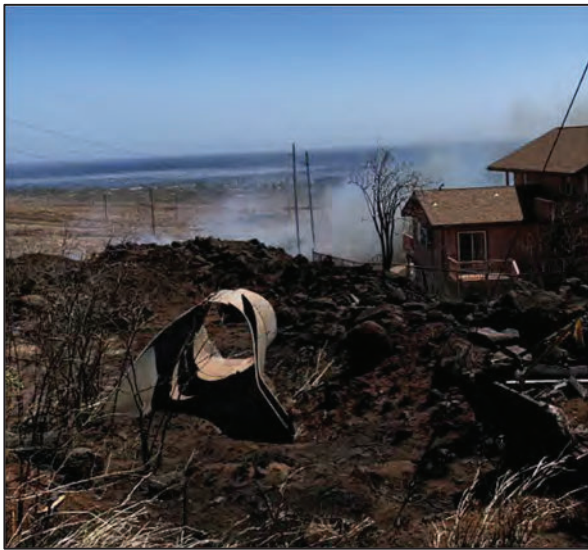
*Figure 26: Still frame from a 2:57 p.m. video captured by a Hawaiian Electric lineman from Lahainaluna Road*

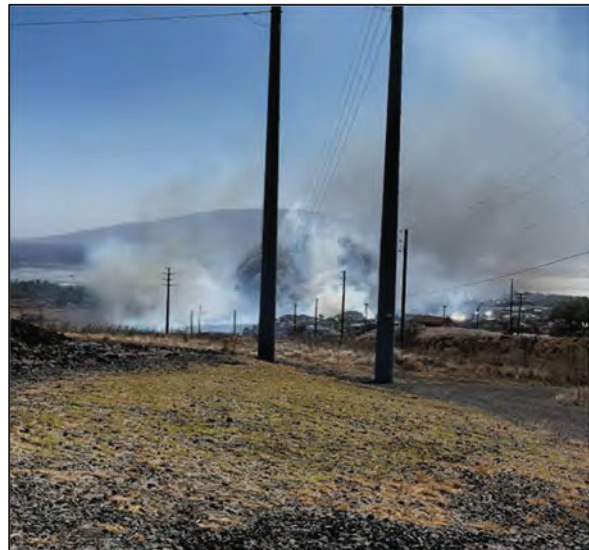
*Figure 27: Still frame from a 3:39 p.m. video captured by a Hawaiian Electric Troubleman from the [REDACTED] Substation*

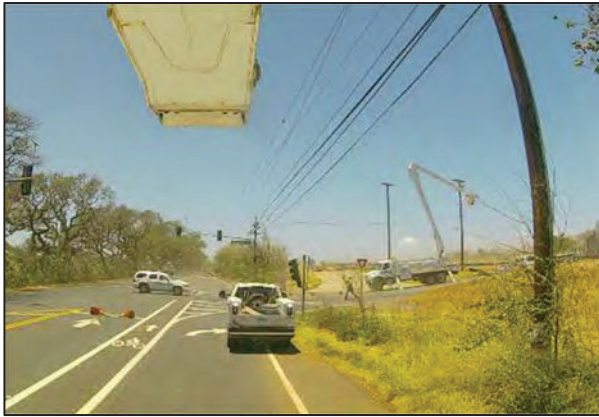
*Figure 31: 12:59 p.m. north-facing dashcam photo captured by a contractor showing poles down across Honoapiilani Highway and a MPD cruiser stopping traffic at Hokiokio Place*

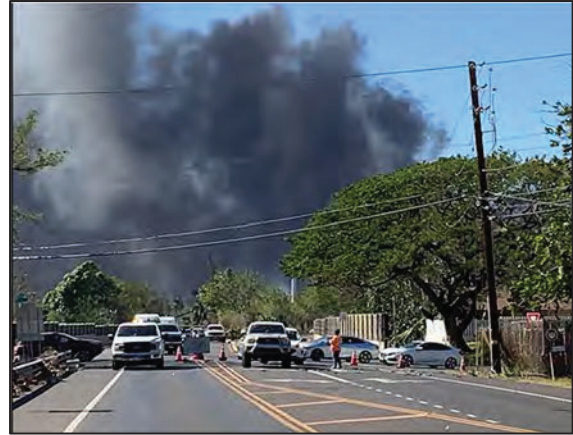
*Figure 32: 4:03 p.m. still frame from a north-facing video captured by a Hawaiian Electric apprentice showing a traffic control contractor blocking traffic southbound at Aholo Road*

Hawaiian Electric understands that the southbound lane of Honoapiilani Highway was briefly open just after 4:00 p.m. By approximately 4:12 p.m., however, three additional poles and lines fell across the intersection of Honoapiilani Highway and Aholo Road, once again blocking the route. Hawaiian Electric crews were already on scene and immediately responded and cleared the poles and cut lines.

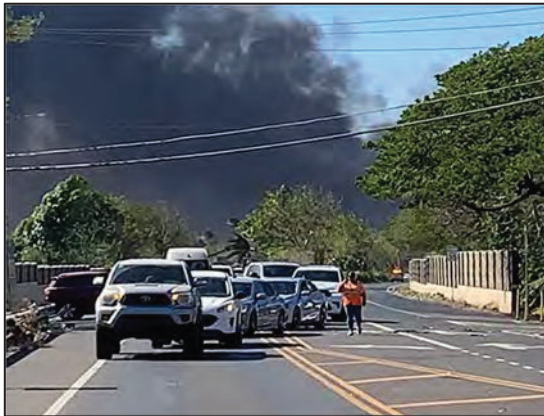
*Figure 33: 4:03 p.m. still frame from a north-facing video captured by a Hawaiian Electric apprentice showing some traffic past Aholo Road*

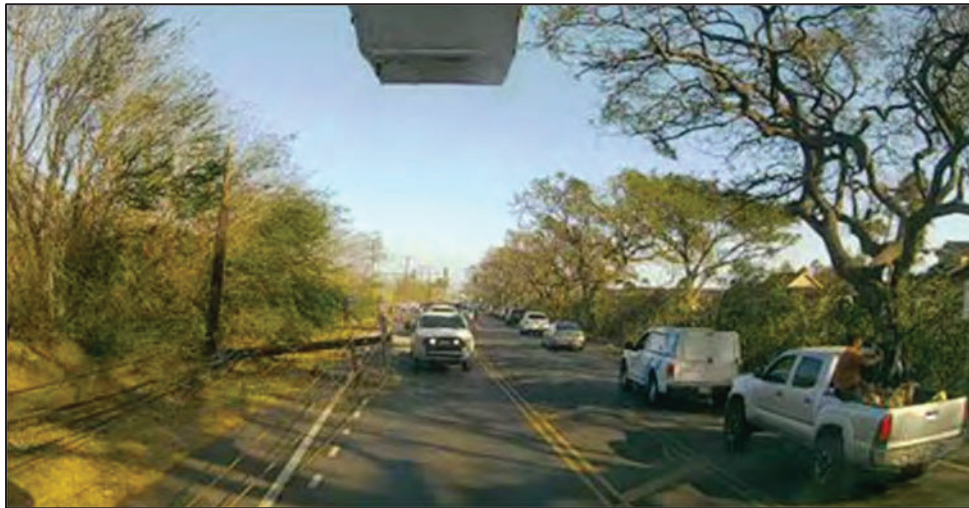
Crews were able to re-open the southbound lane of Honoapiilani Highway at approximately 4:48 p.m. Hawaiian Electric field personnel immediately informed the Control

*Figure 35: 4:50 p.m. south-facing dashcam photo captured by a contractor showing traffic moving southbound while contractors work in the northbound lane of Honoapiilani Highway*

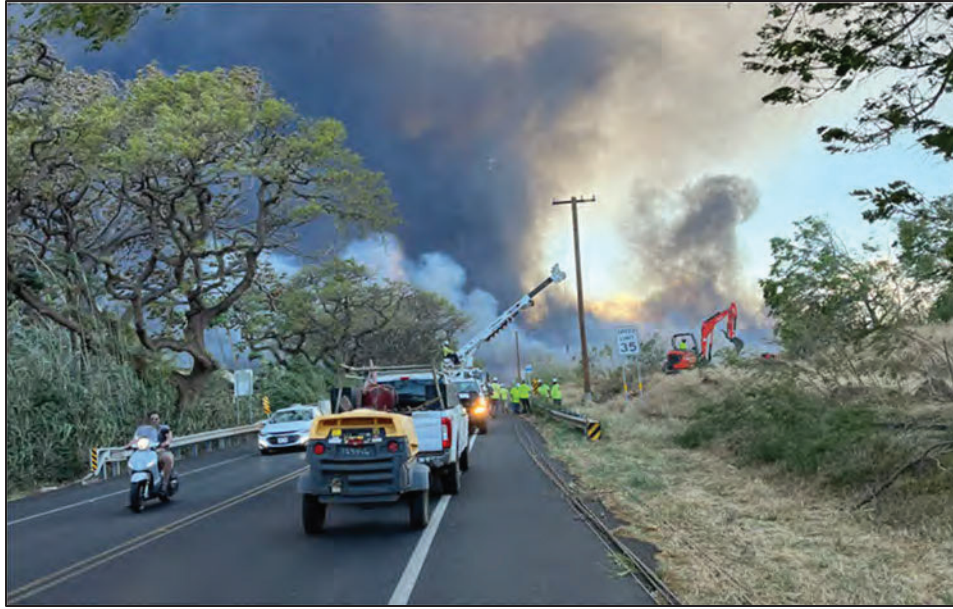
*Figure 36: 6:11 p.m. north-facing photo captured by a contractor showing traffic moving southbound while contractors work in the northbound lane of Honoapiilani Highway*

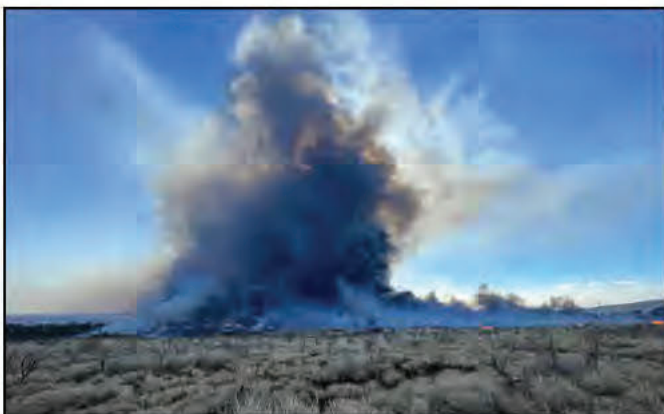
As the Afternoon Fire entered Lahaina town, Hawaiian Electric crews working near Lahainaluna Road were directed by first responders to evacuate at approximately 4:30 p.m. and took up station on the Lahaina Bypass to the south of Lahaina town. From their vantage point on the Lahaina Bypass, crews observed the spread of the fire in the early evening.<sup>51</sup>

*Figure 42: Photo captured by a Hawaiian Electric Lineman at 4:59 p.m. from the Lahaina Bypass south of Lahaina after evacuating Lahainaluna Road*

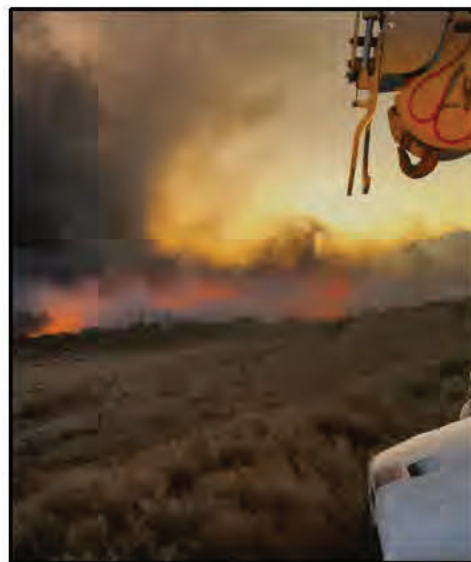
*Figure 43: Still frame from a video captured at 7:17 p.m. from the Lahaina Bypass by the Hawaiian Electric foreman that directed de-energization of the [REDACTED] Line*

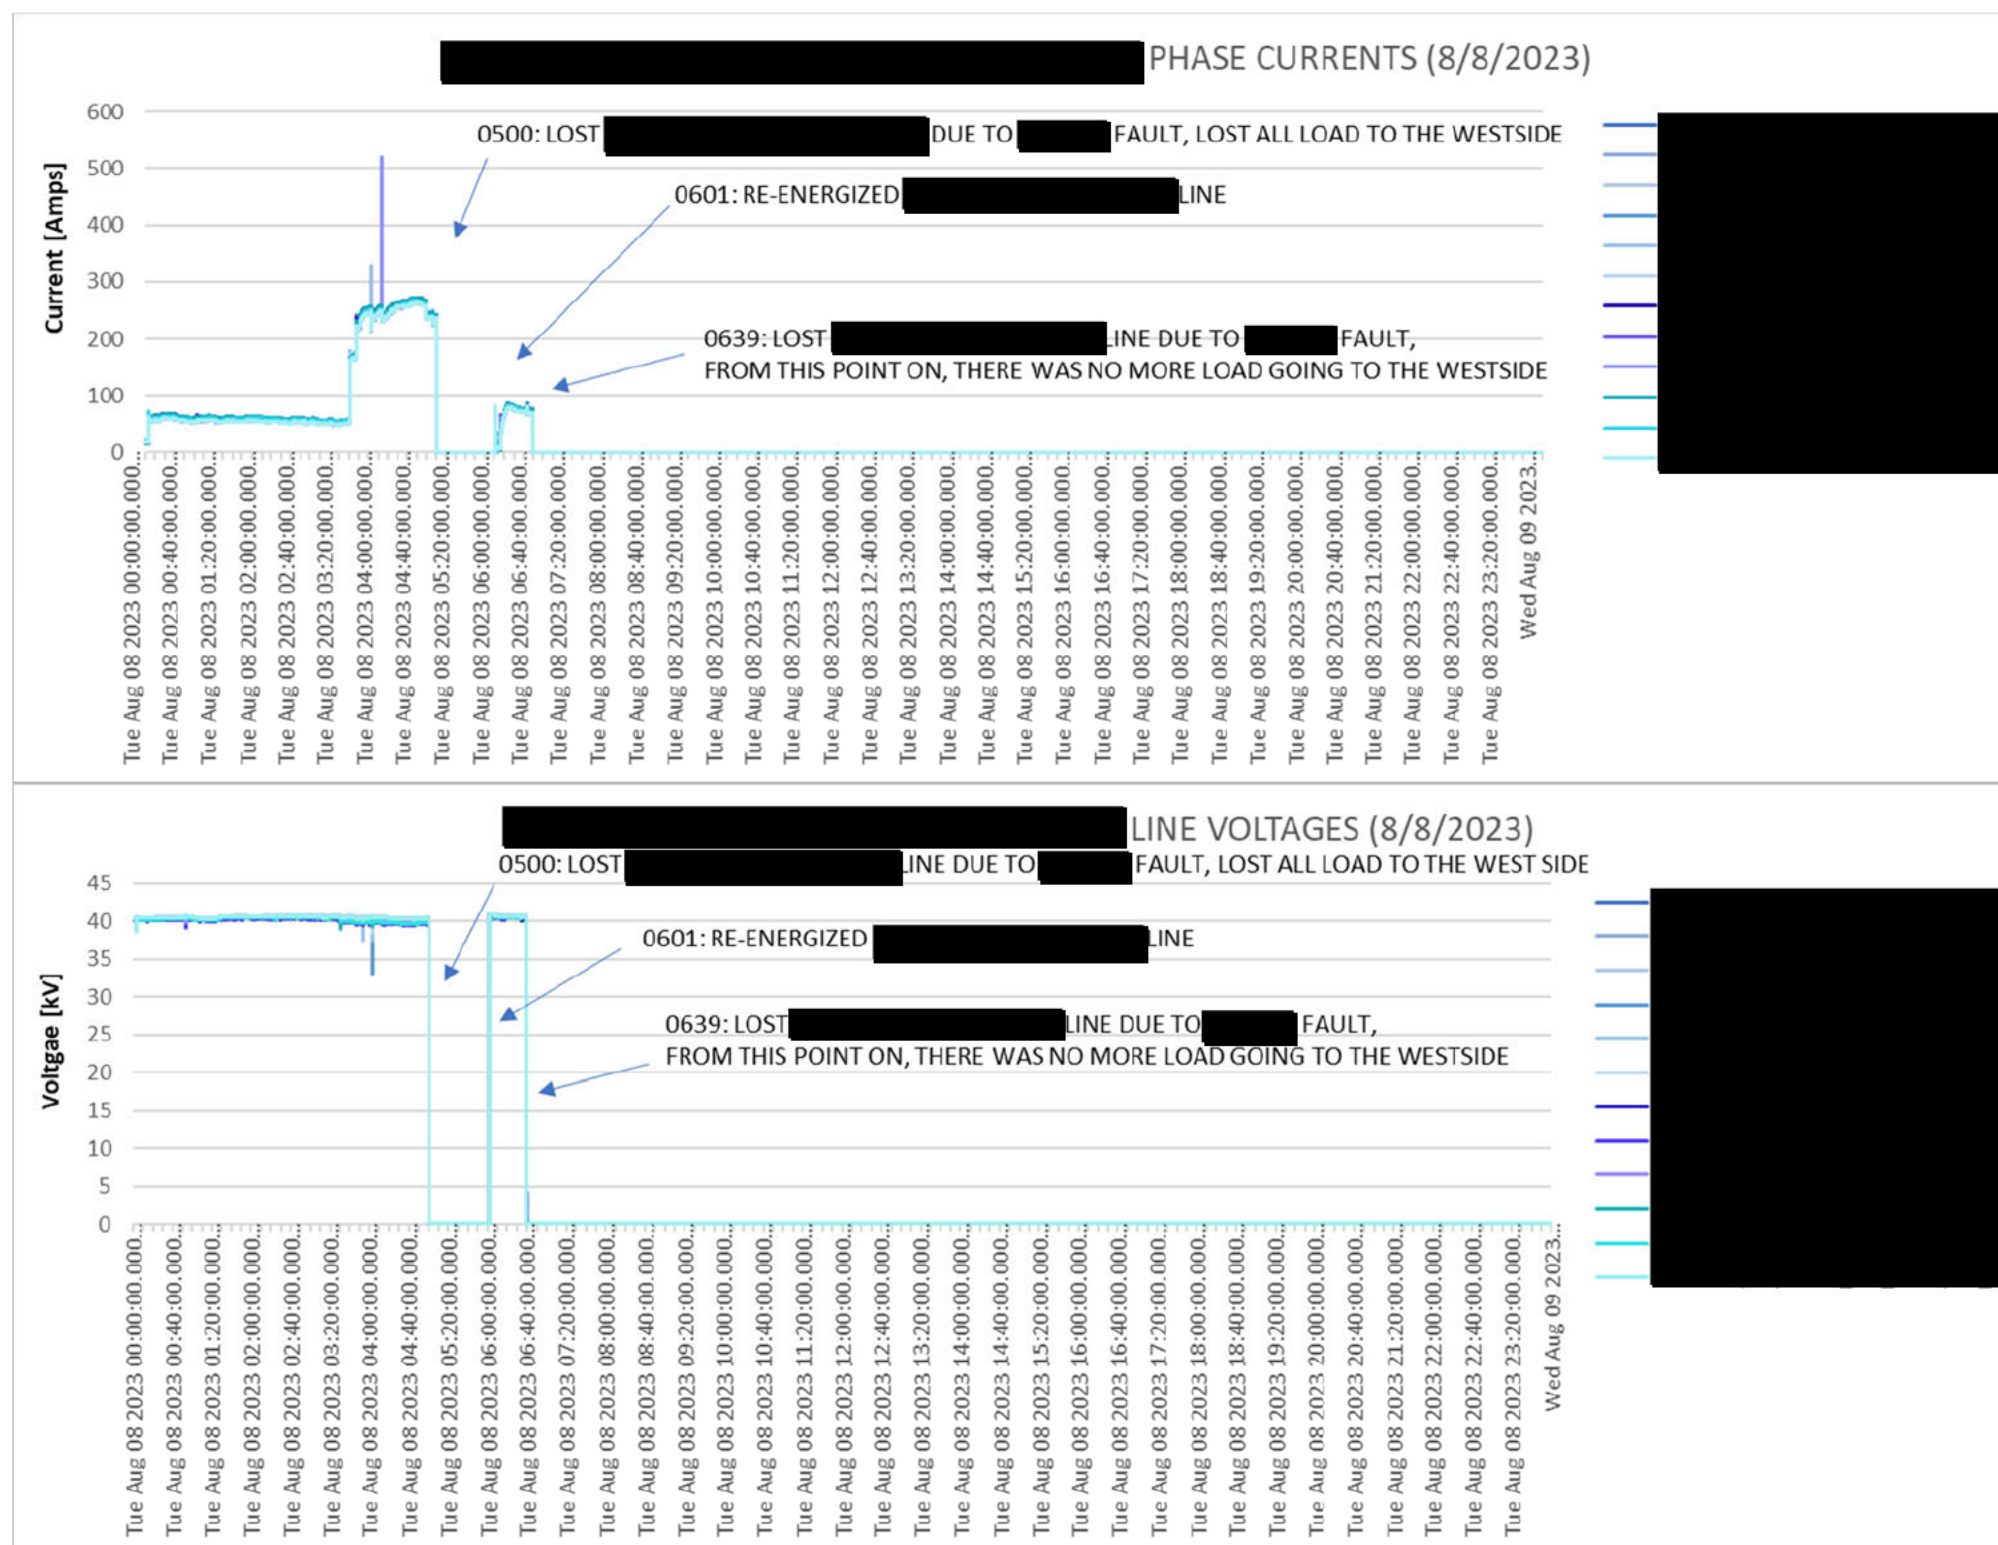
**Graph 1**

- Graph 1 shows current (top) and voltage (bottom) readings transmitted by SCADA from 0000 hours on August 8, 2023 until 0000 hours on August 9, 2023, for the transmission line that ran between the [REDACTED] and the [REDACTED]
- Twelve data plots appear because the provided data for each of the three phases derives from two sets of relays at each end.
- The data show that the line was not energized after 0639 hours on August 8, 2023.
- Source: MECO-ATF-0000001619

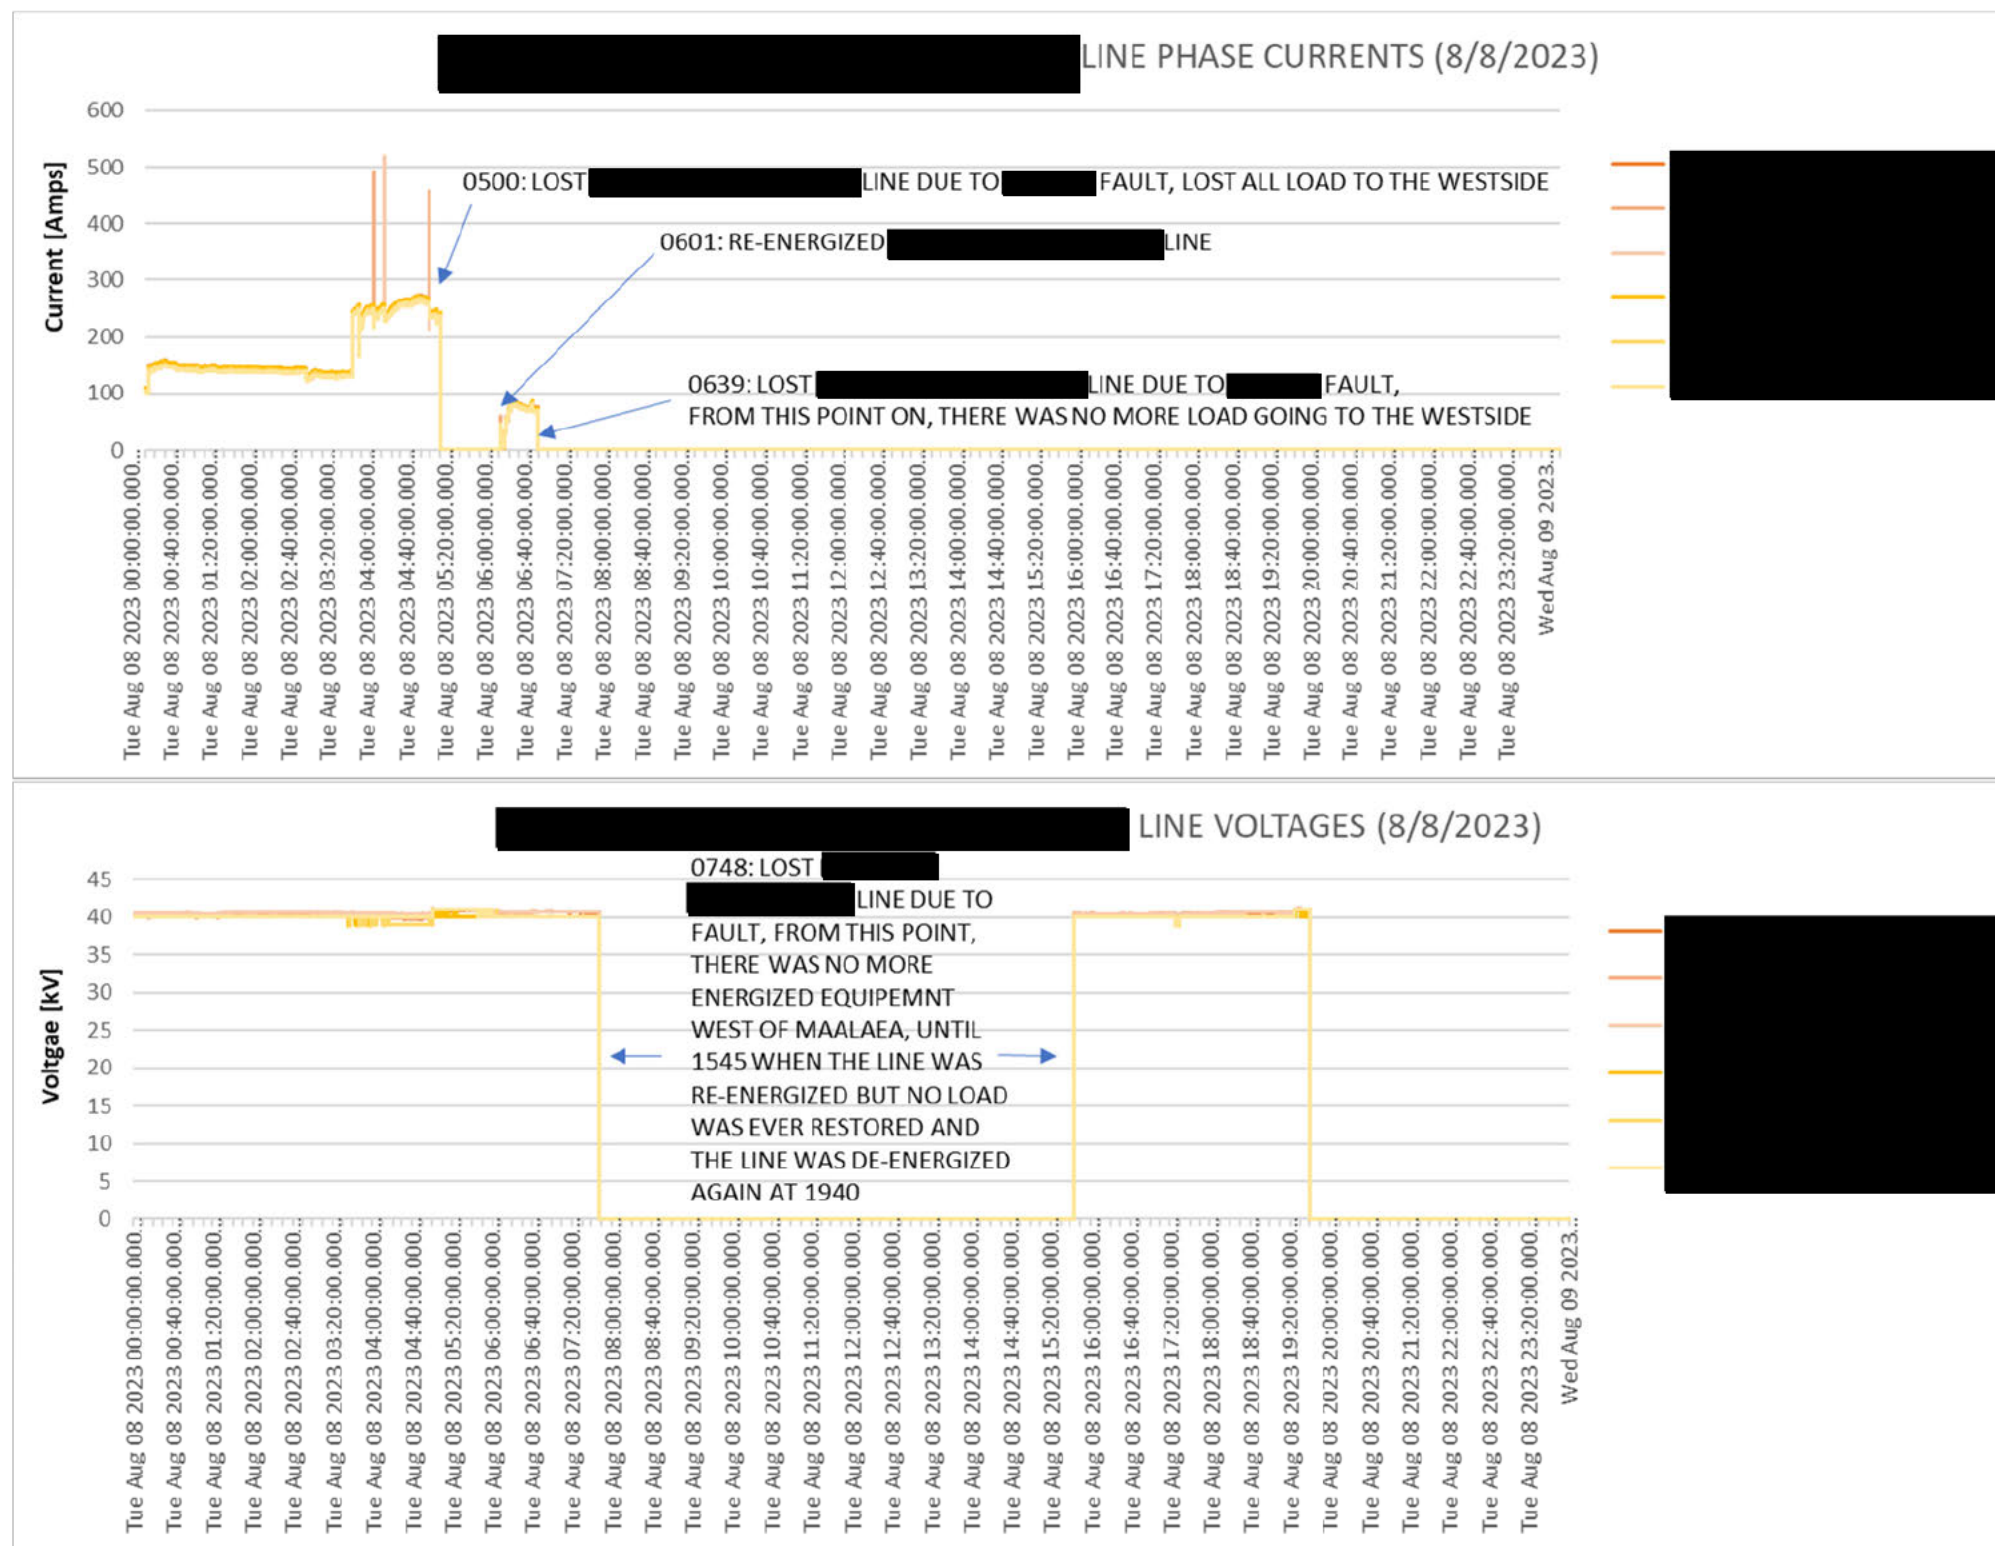
**Graph 3**

- Graph 3 shows current (top) and voltage (bottom) readings transmitted by SCADA from 0000 hours on August 8, 2023 until 0000 hours on August 9, 2023, for the transmission line that ran between the [REDACTED] and the [REDACTED]
- Six data plots appear because the provided data for each of the three phases derives from two relays at the [REDACTED]
- The voltage data shows that the line tripped at 0748 hours, although no current flowed after 0639 hours after the downstream transmission line between the [REDACTED] and the [REDACTED] tripped, as no load was being served after that time.
- The line was not re-energized until 1545 hours. When it was re-energized, nothing downstream of the [REDACTED] was energized, so no loads were restored and therefore no current was flowing.
- Source: MECO-ATF-0000001619

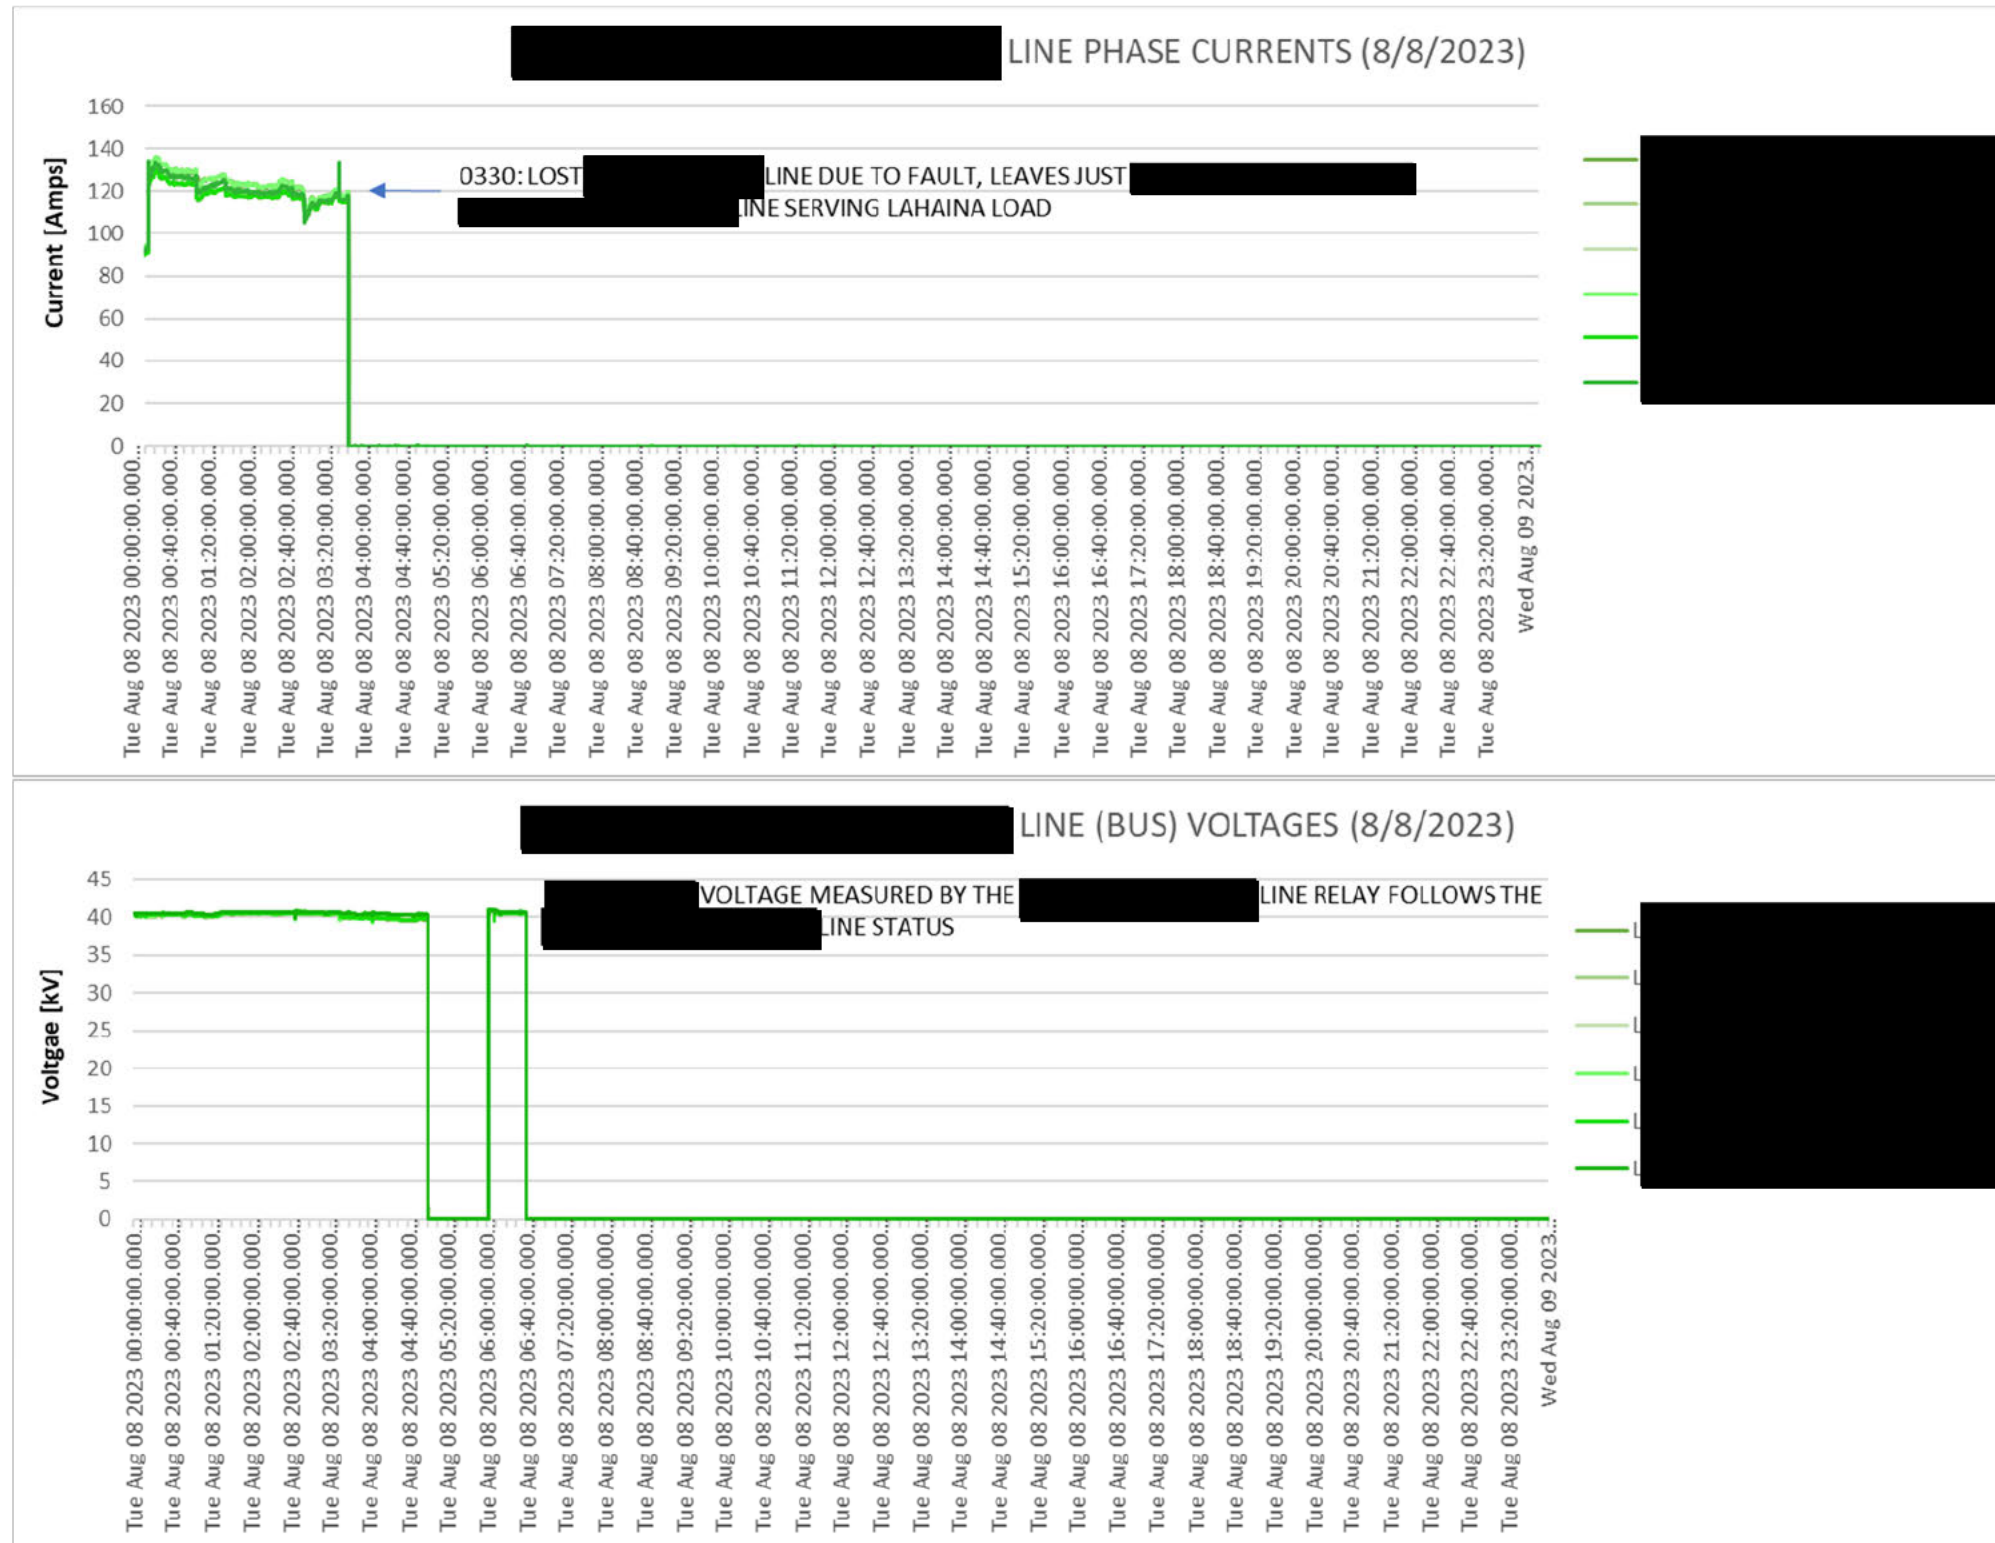
#### Graph 4

- Graph 4 shows current (top) and voltage (bottom) readings transmitted by SCADA from 0000 hours on August 8, 2023 until 0000 hours on August 9, 2023, for the transmission line that ran from the [REDACTED] to the [REDACTED]
- Six data plots appear because the provided data for each of the three phases derives from two relays at the [REDACTED]
- The current data indicate that the line tripped at 0330 and current did not flow on the line afterwards.
- The relay voltage value input to SCADA is measured on the substation side of the breaker and took voltage readings when the substation was energized from 0601 hours to 0639 hours, even though this line was not energized at that time.
- Source: MECO-ATF-0000001619

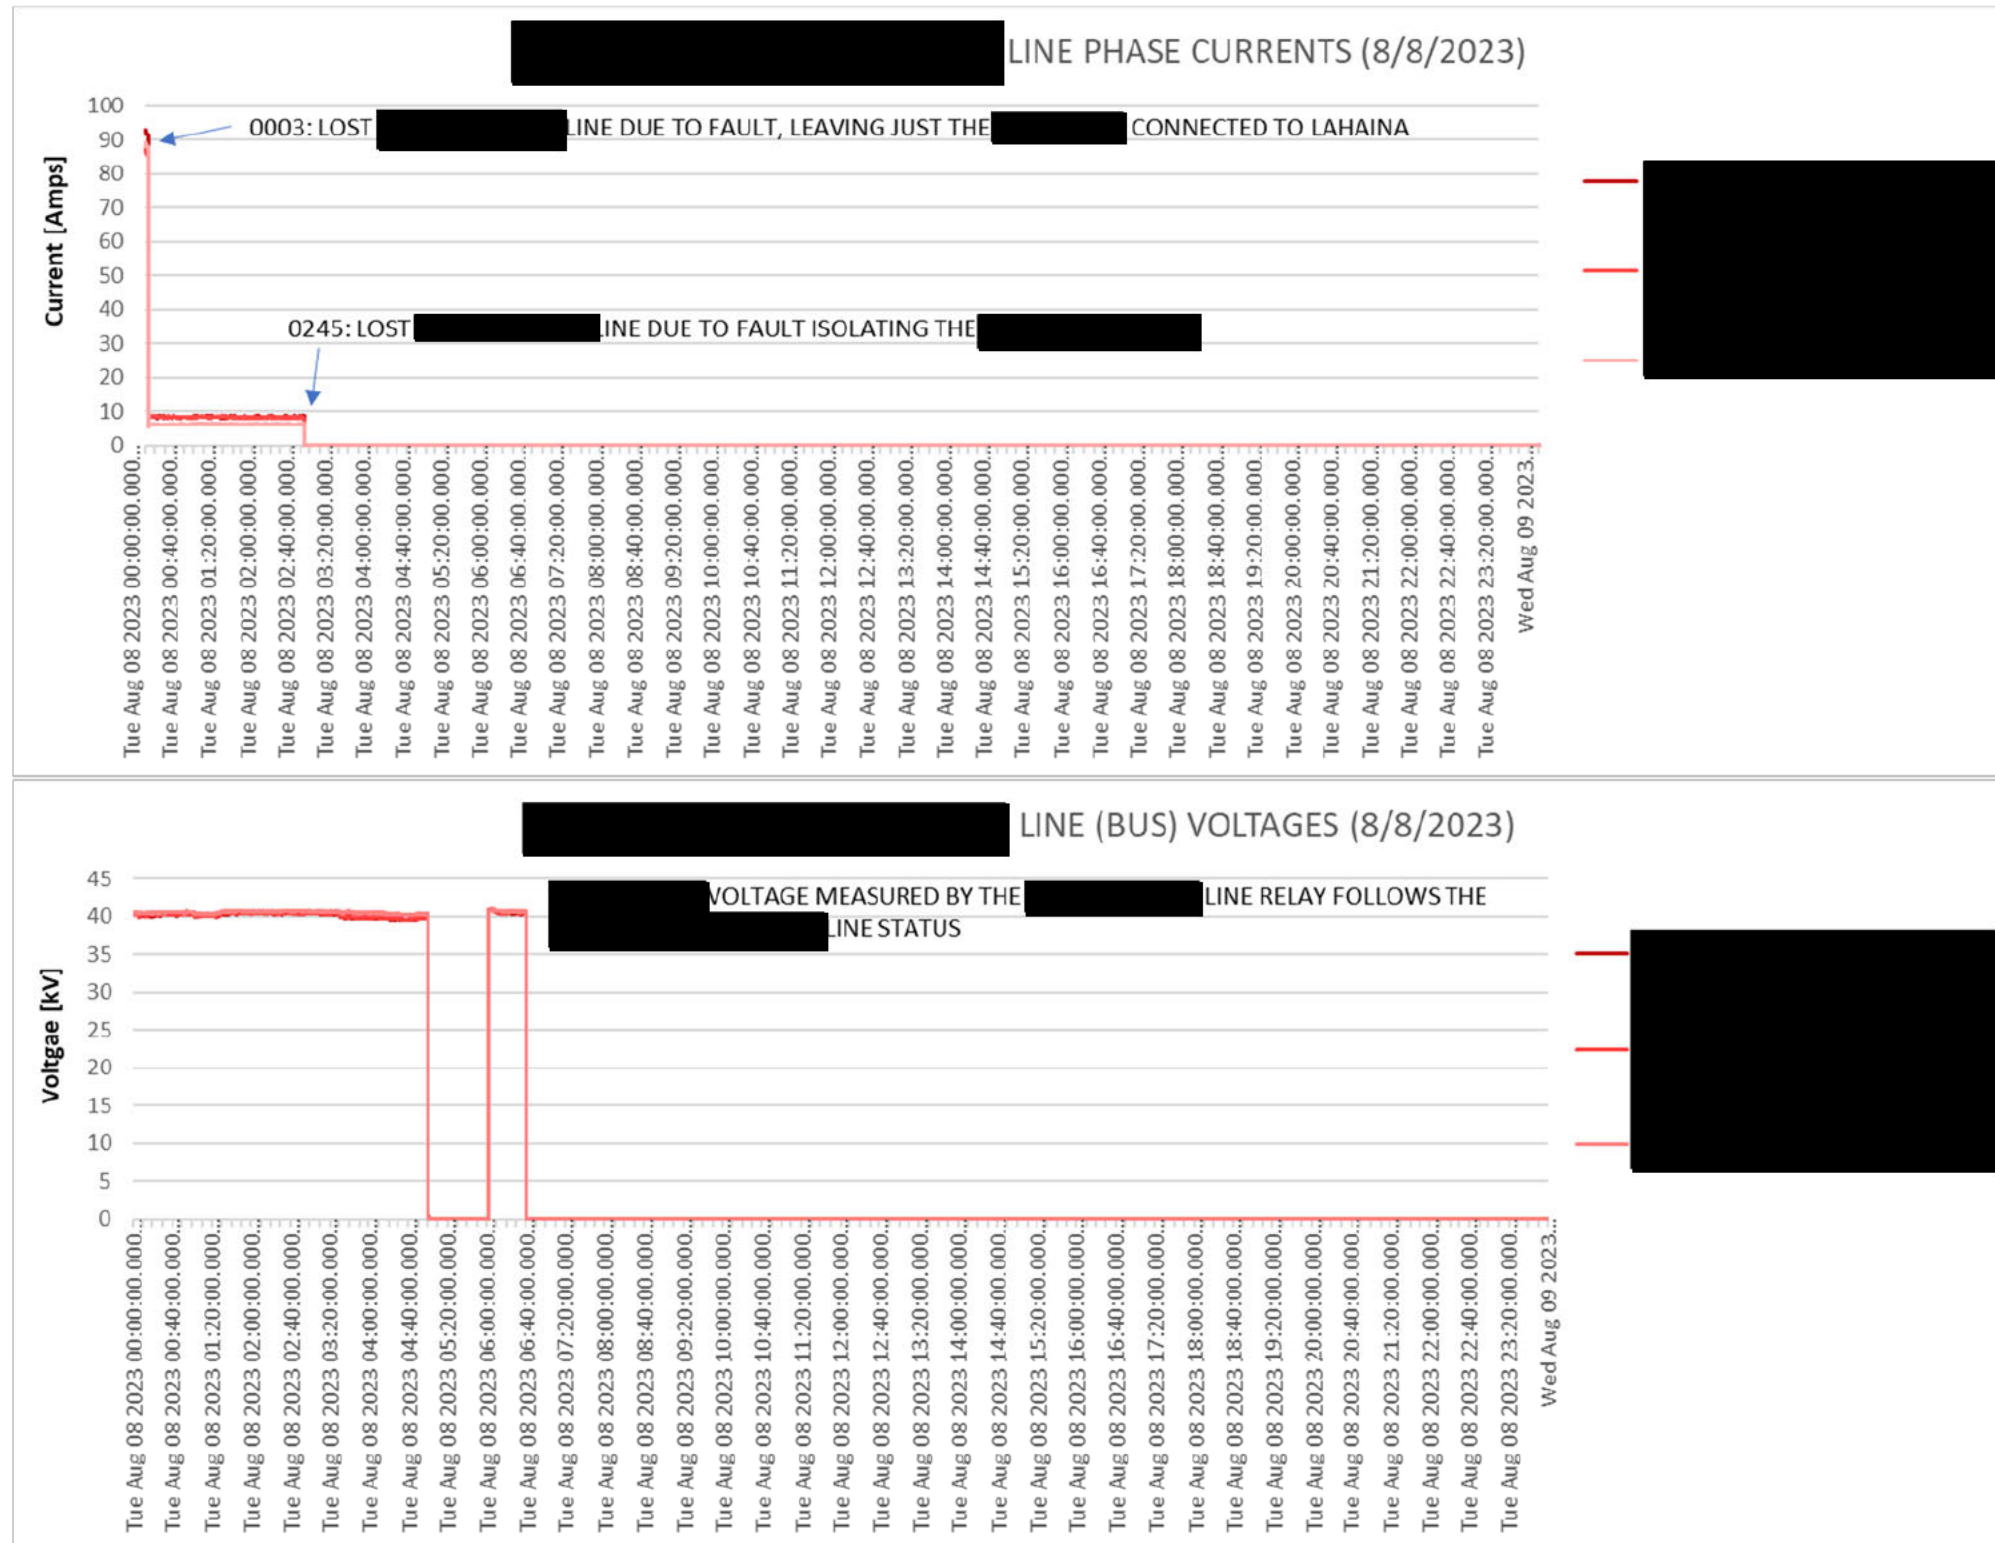
### Graph 5

- Graph 5 shows current (top) and voltage (bottom) readings transmitted by SCADA from 0000 hours on August 8, 2023 until 0000 hours on August 9, 2023, for the transmission line that ran from the [REDACTED] to the [REDACTED].
- The current data indicate that the [REDACTED] to [REDACTED] tripped off at 0003 hours, which explains the drop in amperage from approximately 90 amps to below 10 amps until 0245 hours. After that portion of the line tripped, current to the [REDACTED] on this line was solely from the [REDACTED] until 0245, when the portion of the transmission line between the [REDACTED] and the [REDACTED] tripped offline.
- The relay voltage value input to SCADA is measured on the substation side of the breaker and took voltage readings when the substation was energized from 0601 hours to 0639 hours, even though this line was not energized at that time.
- Source: MECO-ATF-0000001619

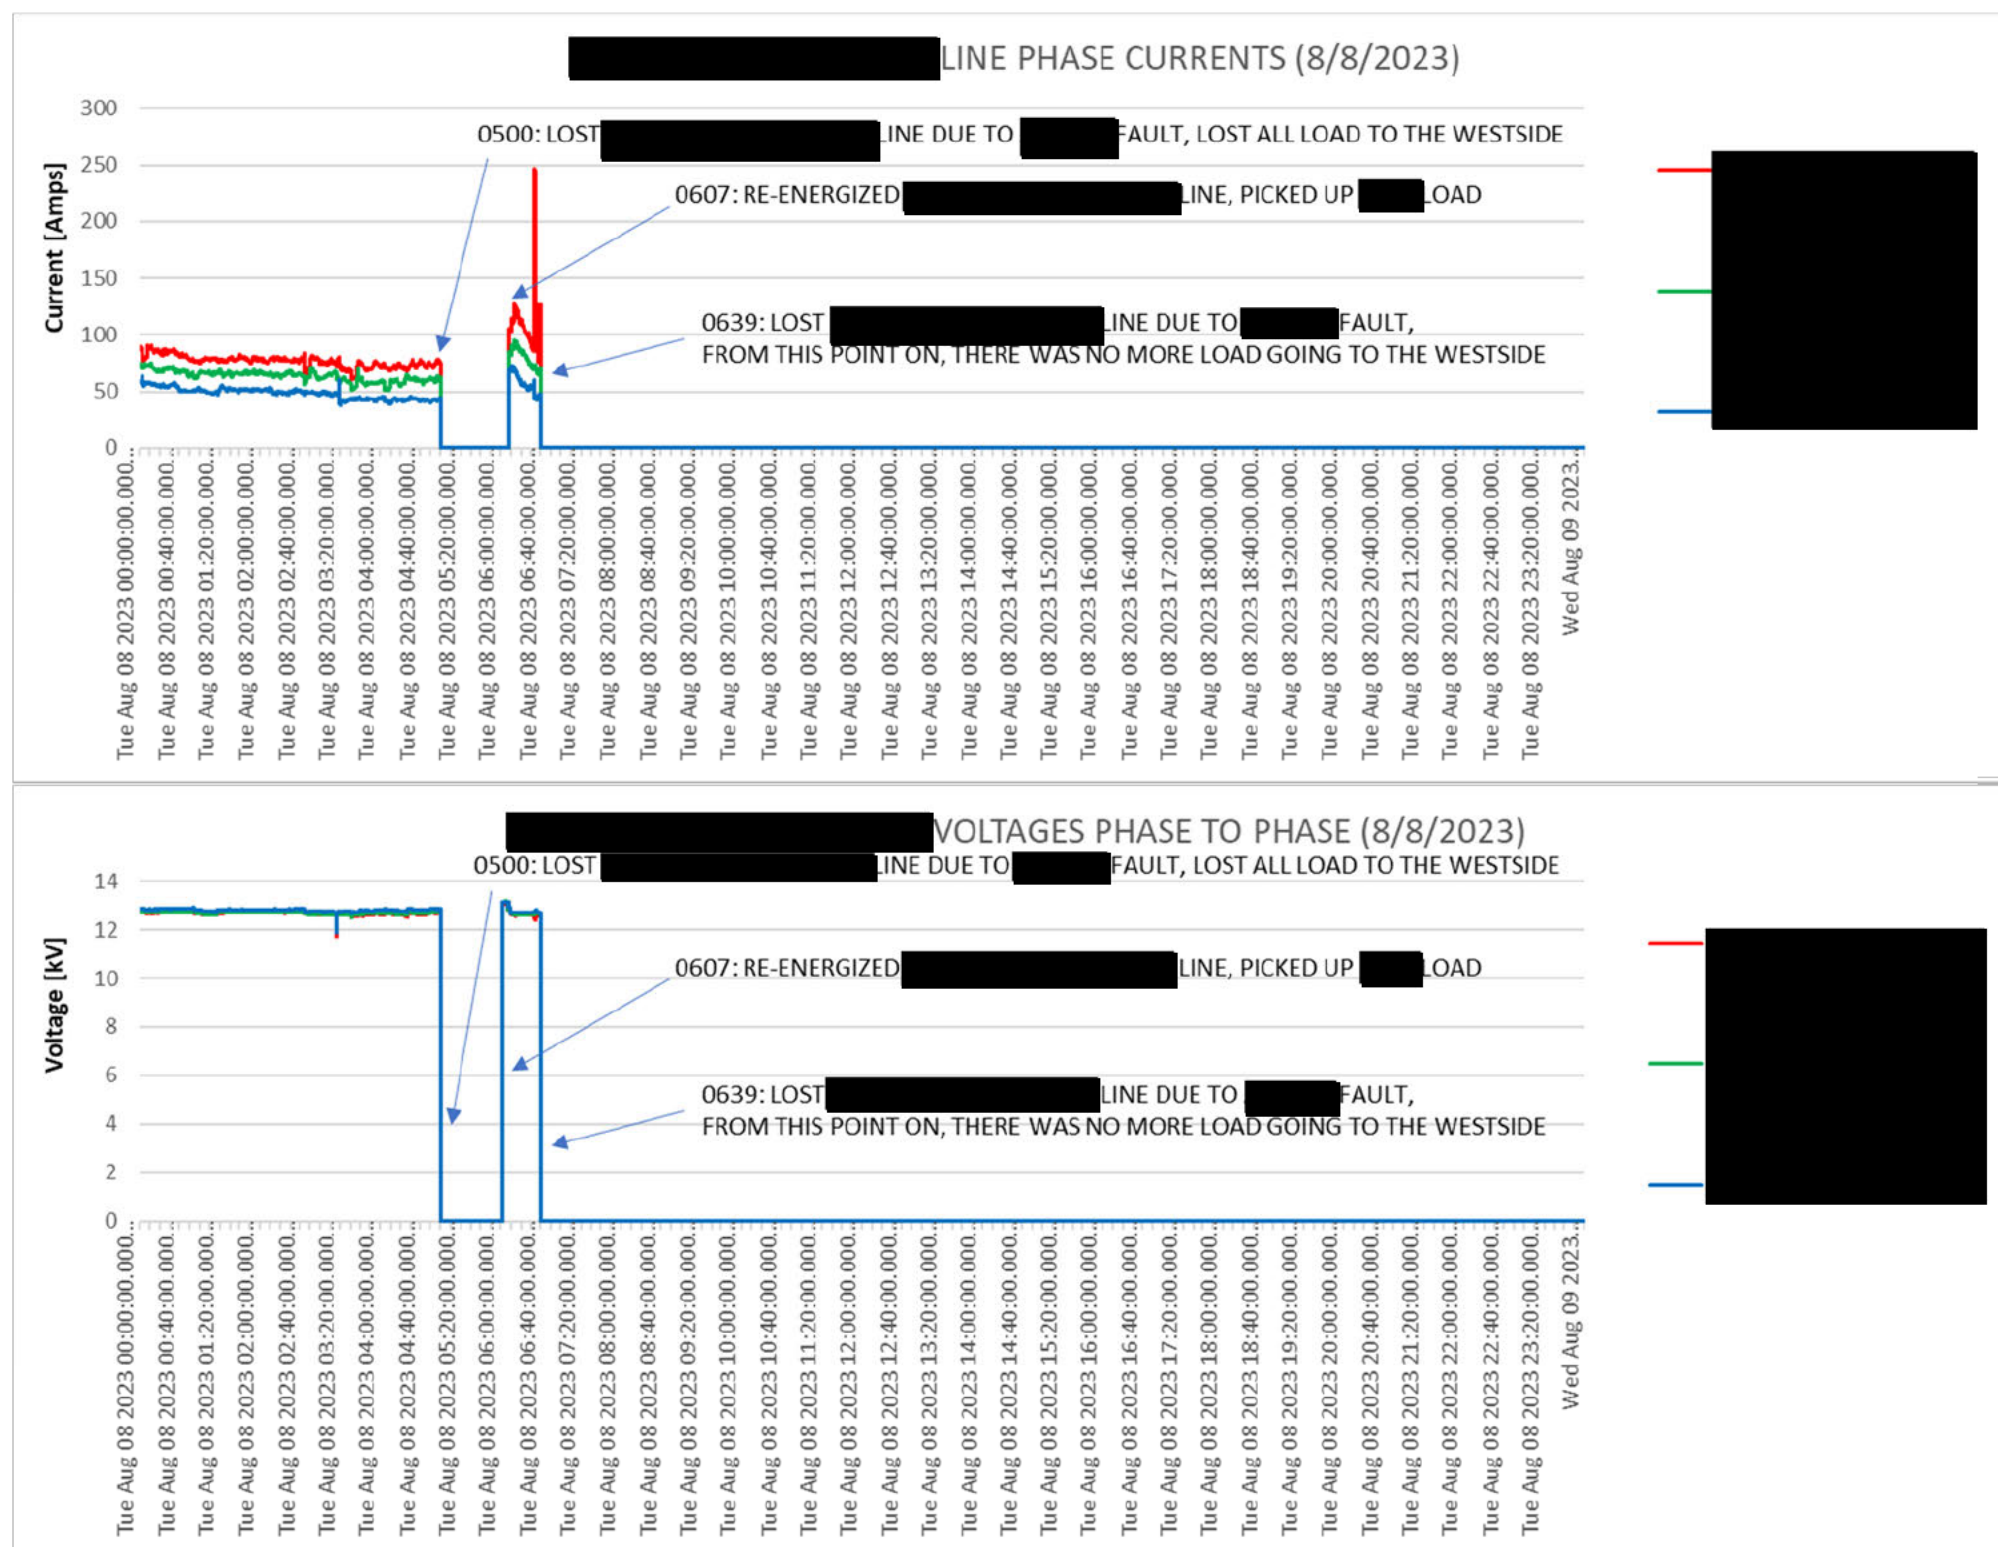
**Graph 6**

- The top graph shows current readings transmitted by SCADA from 0000 hours on August 8, 2023 until 0000 hours on August 9, 2023, for all three phases of [REDACTED] line [REDACTED] from the feeder circuit relay at the [REDACTED]
